## High energy ion beam analysis of cultural heritage objects, a study of provenance and manufacturing techniques

# High energy ion beam analysis of cultural heritage objects, a study of provenance and manufacturing techniques

## Historical context and questions concerning the object

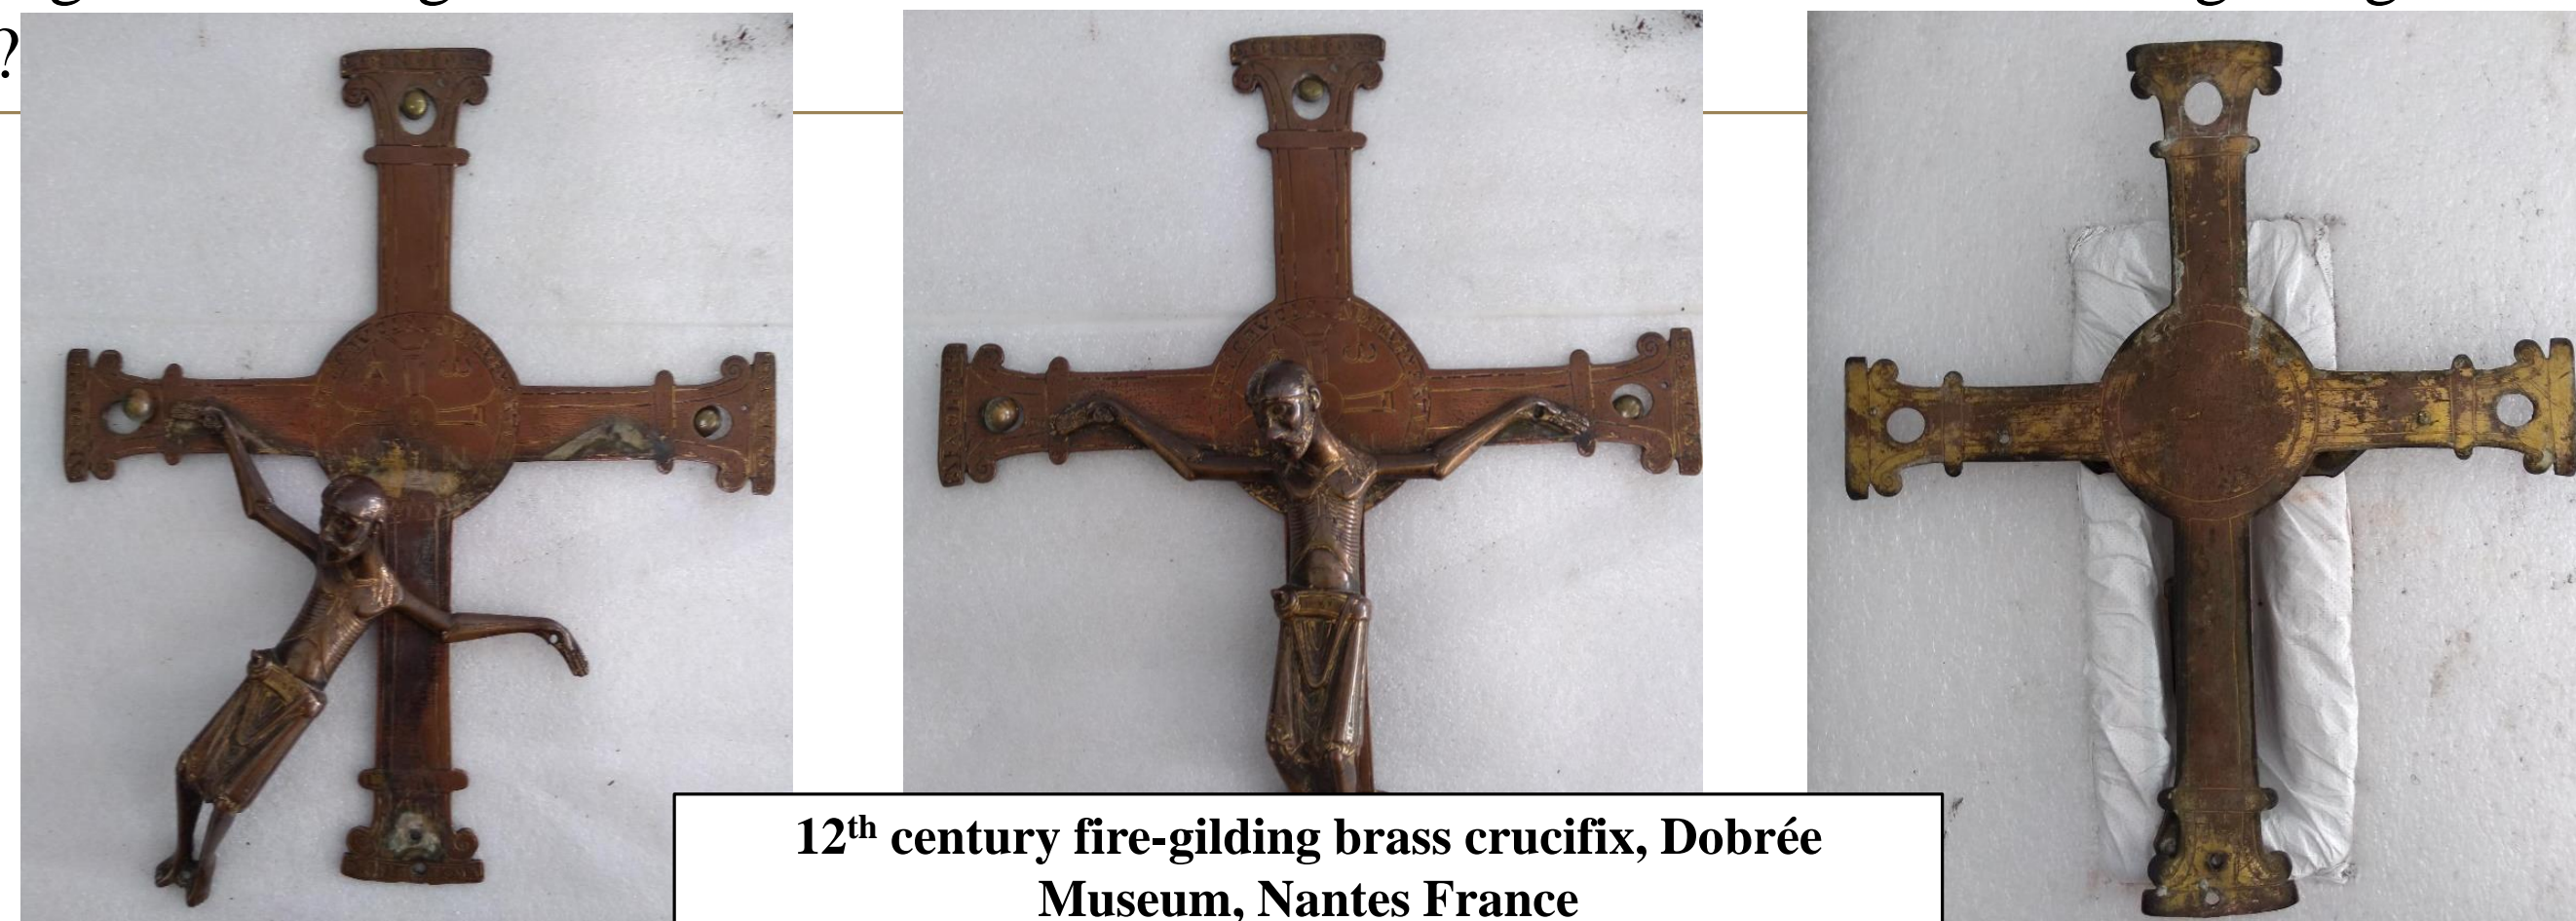
12th century fire-gilding brass crucifix, Dobrée Museum, Nantes France

We studied a 12th century Romanesque crucifix. Fire-gilding was used to cover the Christ and his cross. The study of coating thickness can improve the understanding of the manufacturing technique used in the case of fire-gilding on a brass alloy [1].

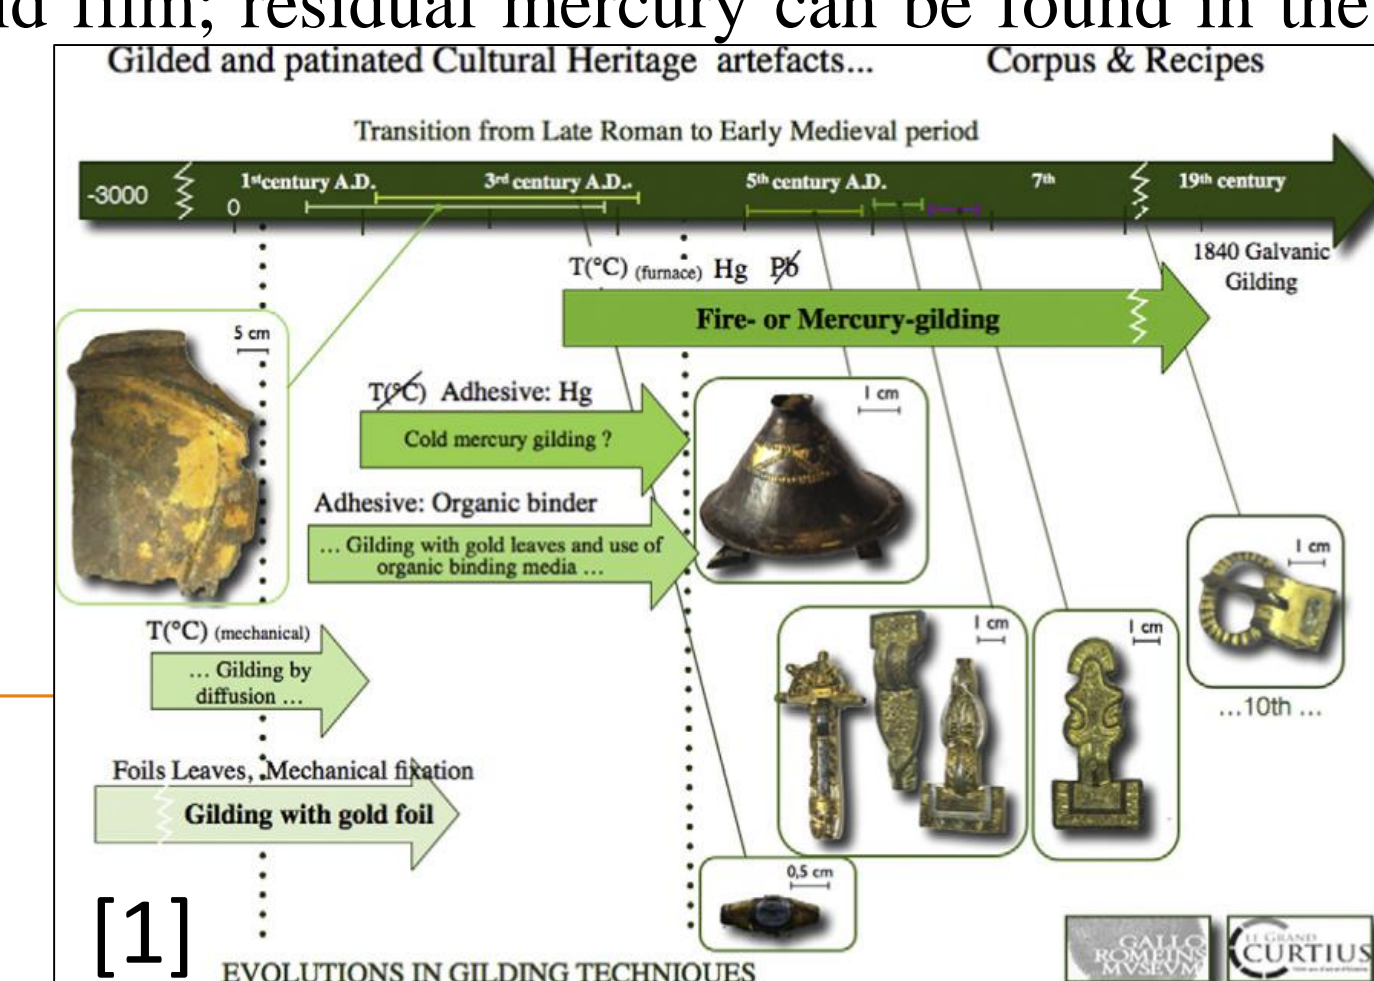
### Fire gilding technique:

Fire gilding has been performed from 3rd to 19th century to decorate objects mainly bronze and brass statuette. It is a diffusion bonding process. The role of the mercury is to ensure a close contact of substrate and plating. There is a solid-state reaction involving the use of a paste of Au-Hg amalgam (Au<sub>2</sub>Hg) [2].

**Step n°1 - Grinding gold dust with mercury;** it requires a clean and oxide-free metal substrate

**Step n°2 - Thermal treatment;** it takes a few minutes by heating in air at about 250–350°C (< Hg boiling point at 357°C)

**Step n°3 - Mechanical finishing** using burnishers

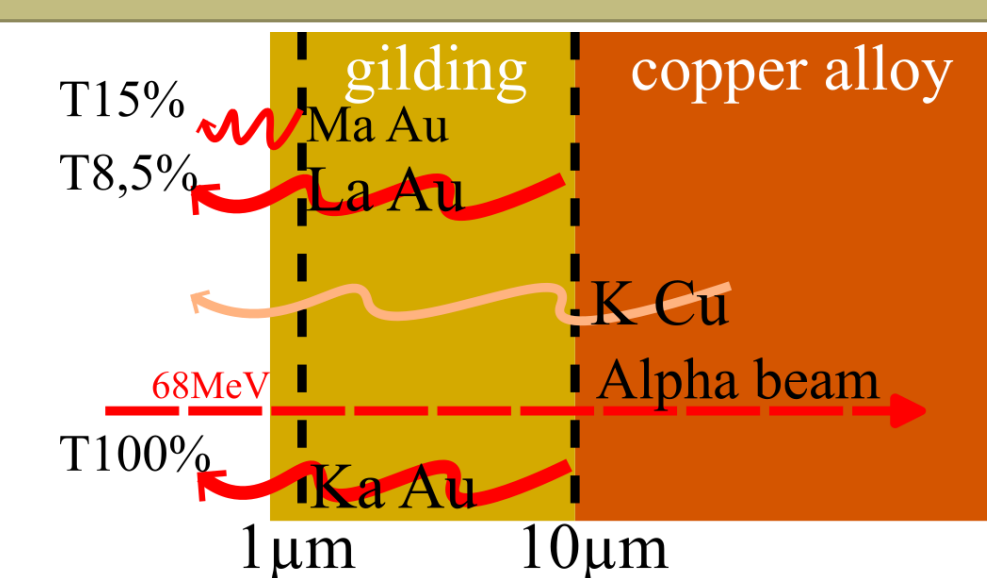
For our purpose, coating thickness measurement can be done with the net intensity of Au K-X ray line (because self attenuation is negligible, see diagram beside). Furthermore, the gilding quality was evaluated by studying the variation of the ratios  $K\alpha/K\beta$  of copper in gold.

Specific X-ray lines attenuated through gilding layer and copper matrix

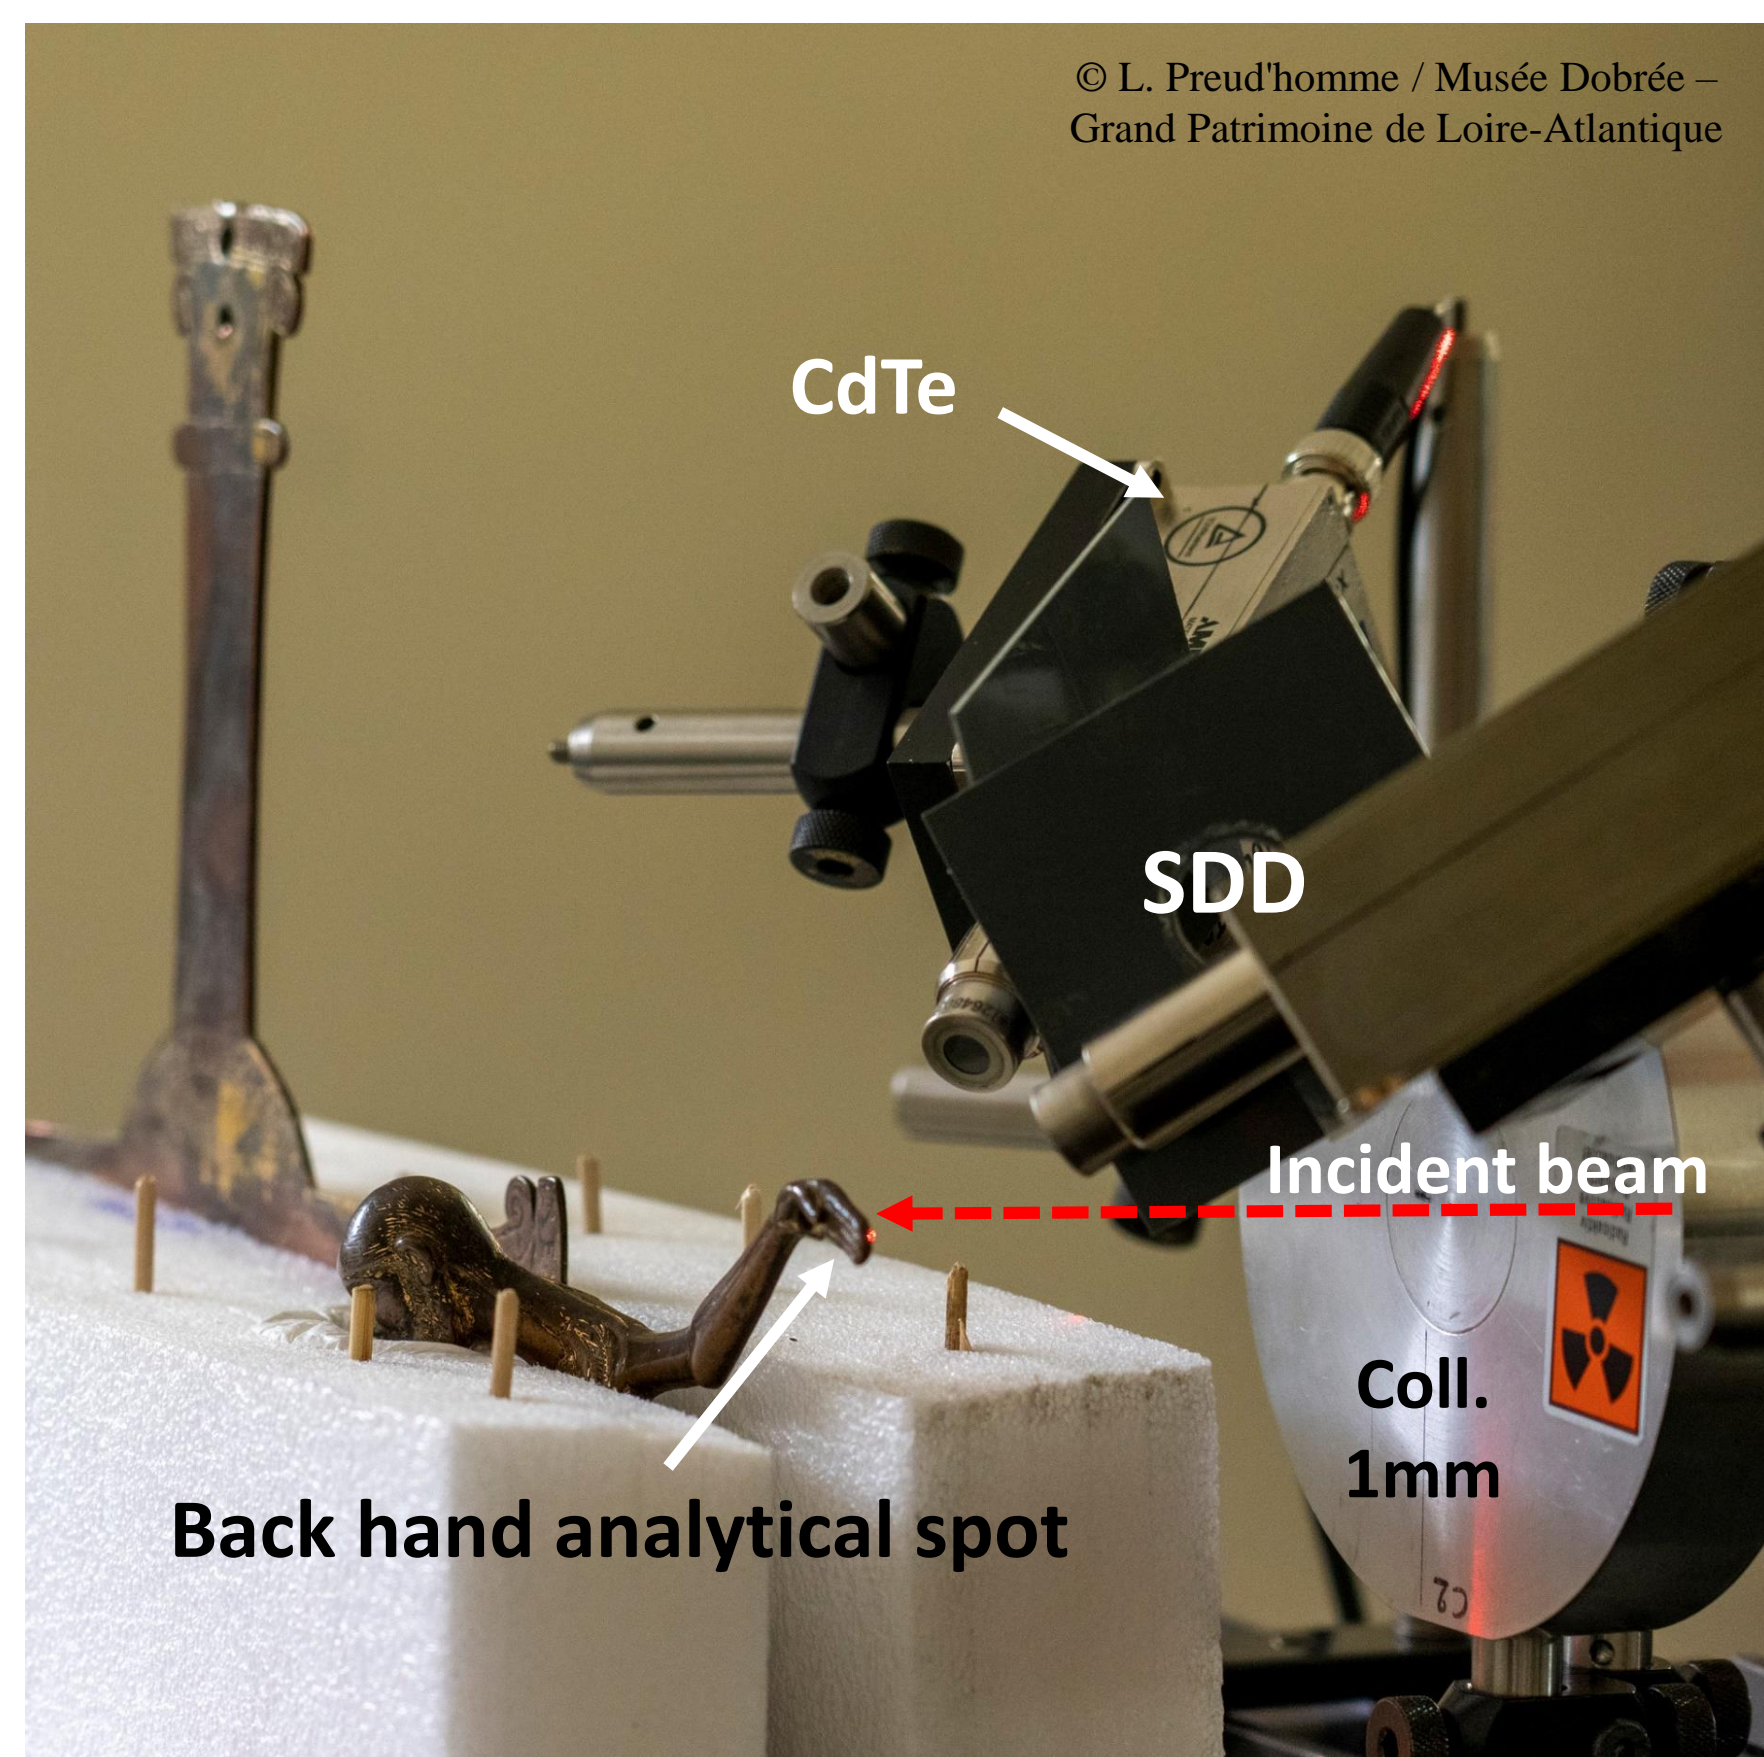
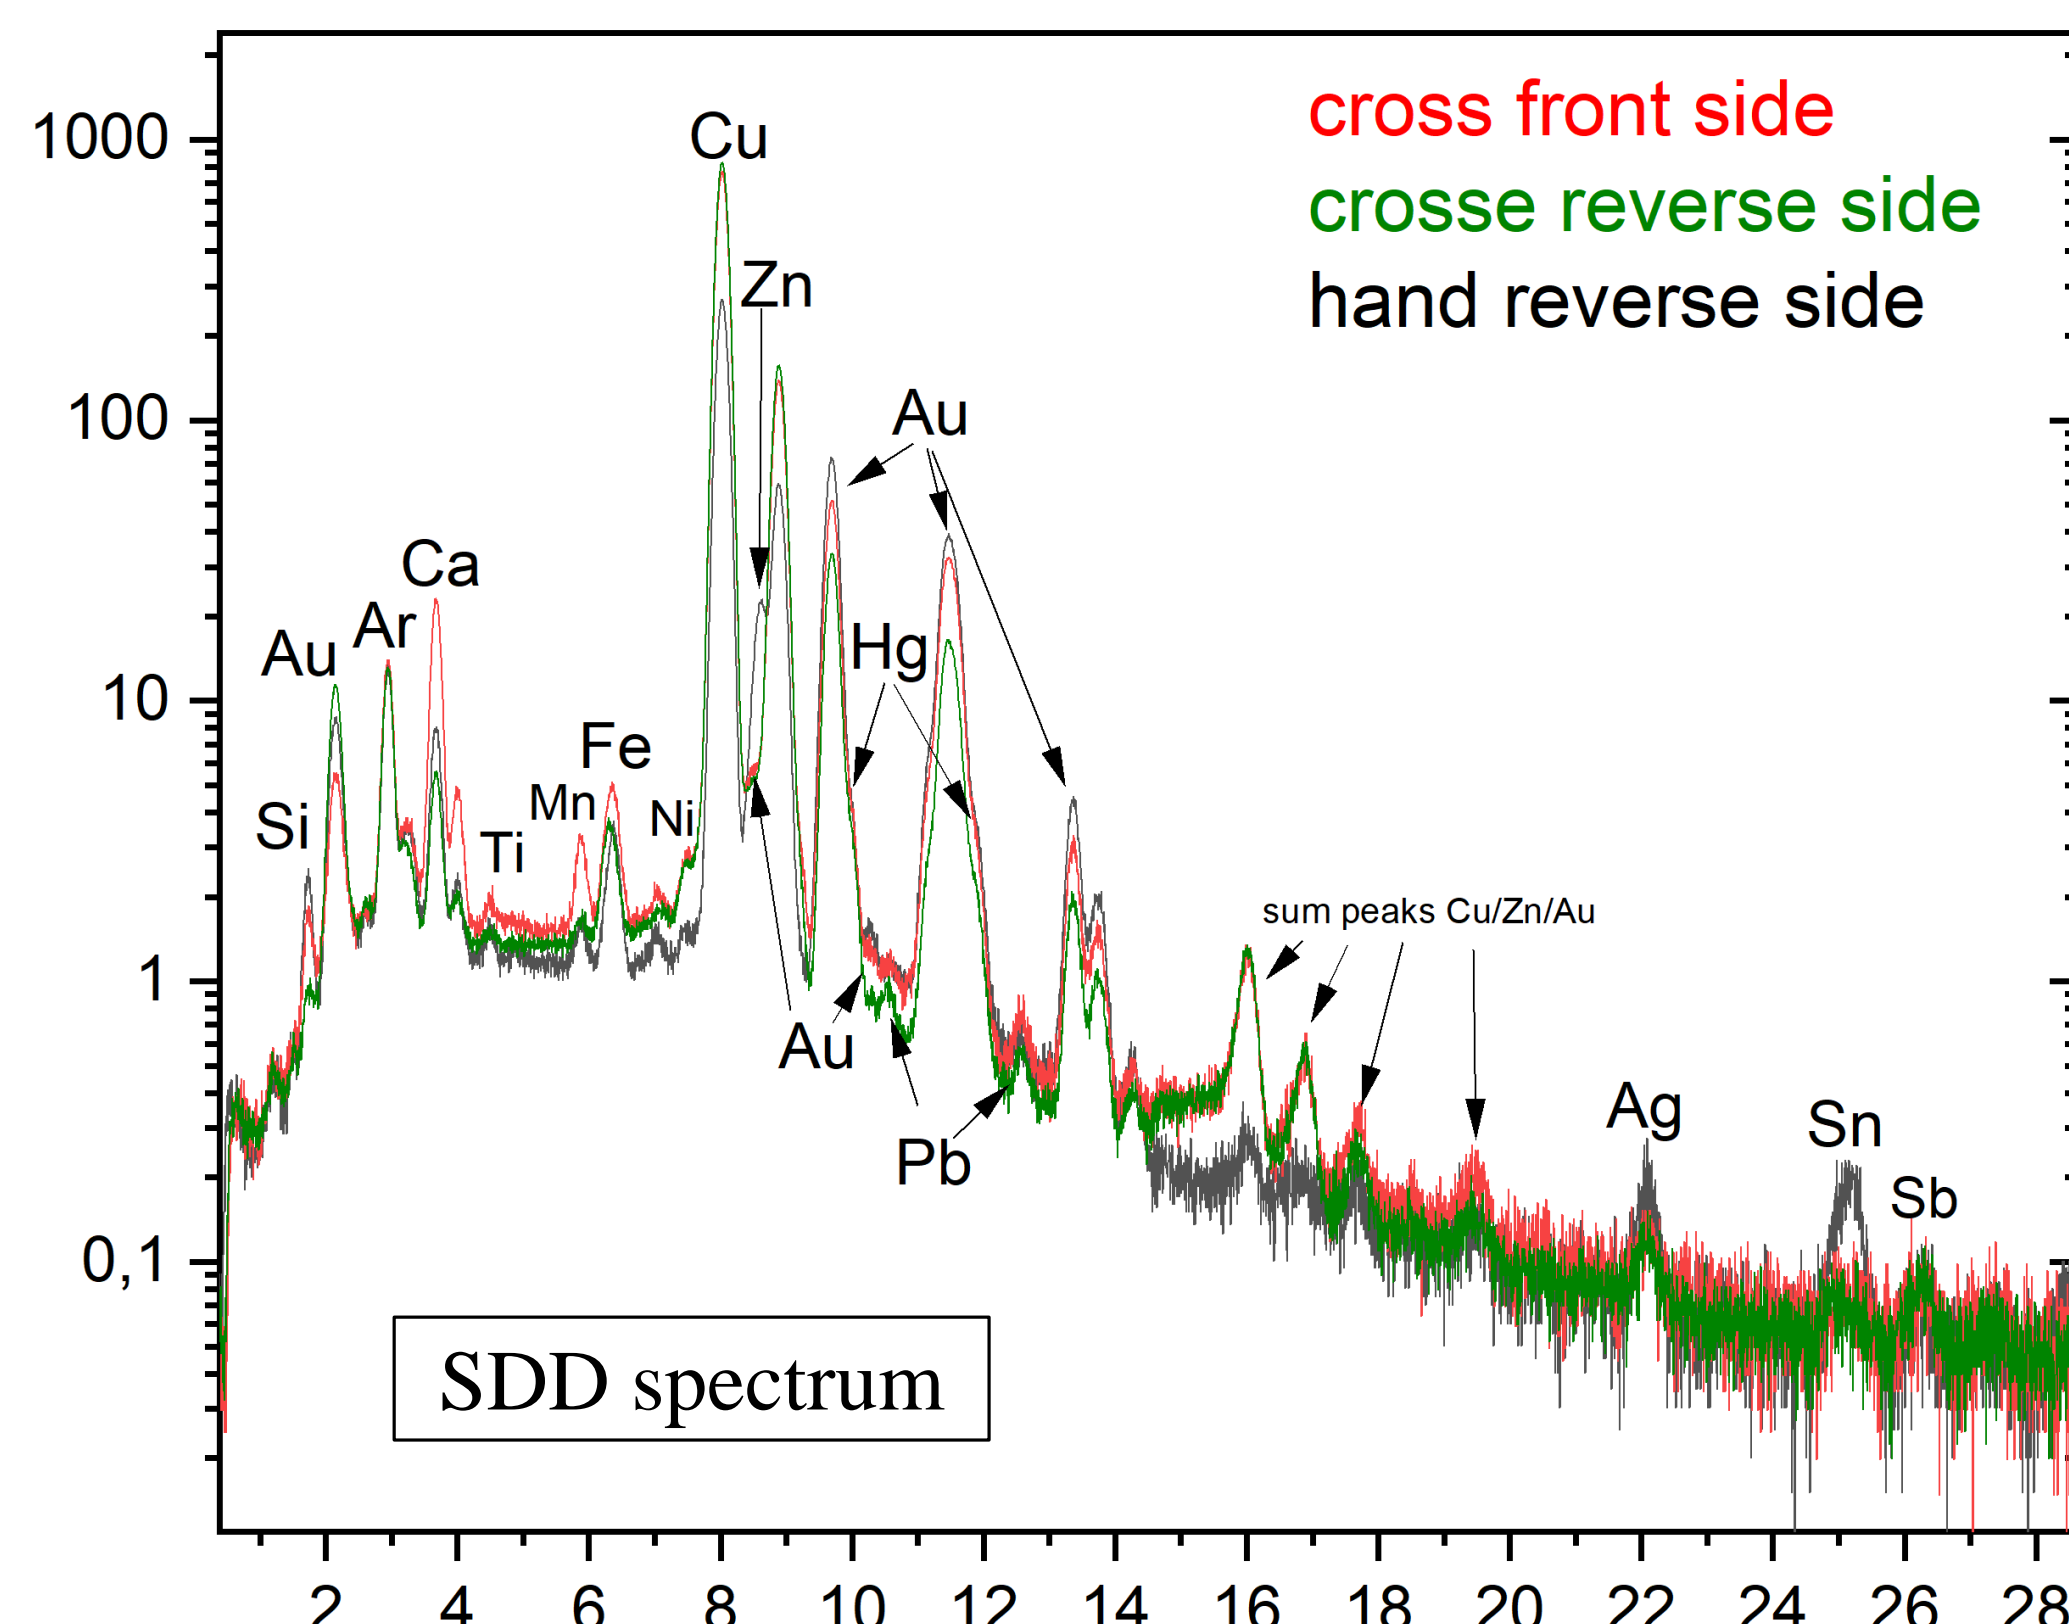
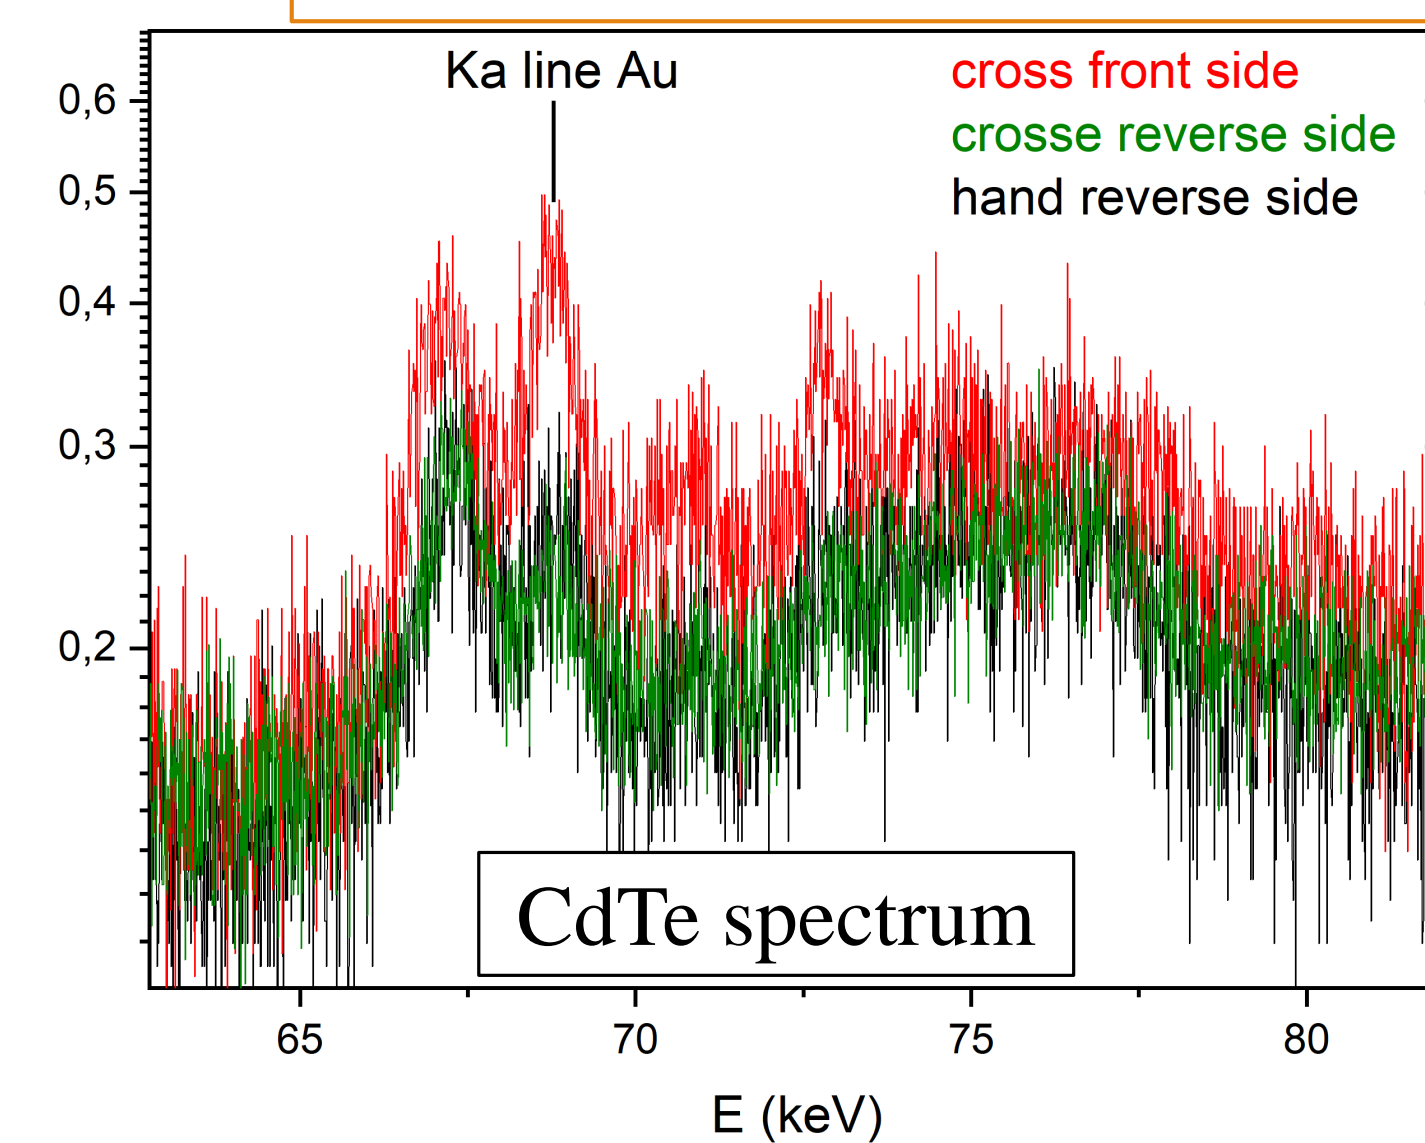
Cu/Zn	brass
Sn/Pb/Sb/Ti/Mn/Fe/Ni	alloying additions
Au/Hg/Ag	gilding
Si	SDD detector
Ar	air
Ca	surface contaminant

Coupling SDD for low energy X-rays (<15keV) with CdTe for higher energies up to 100keV.

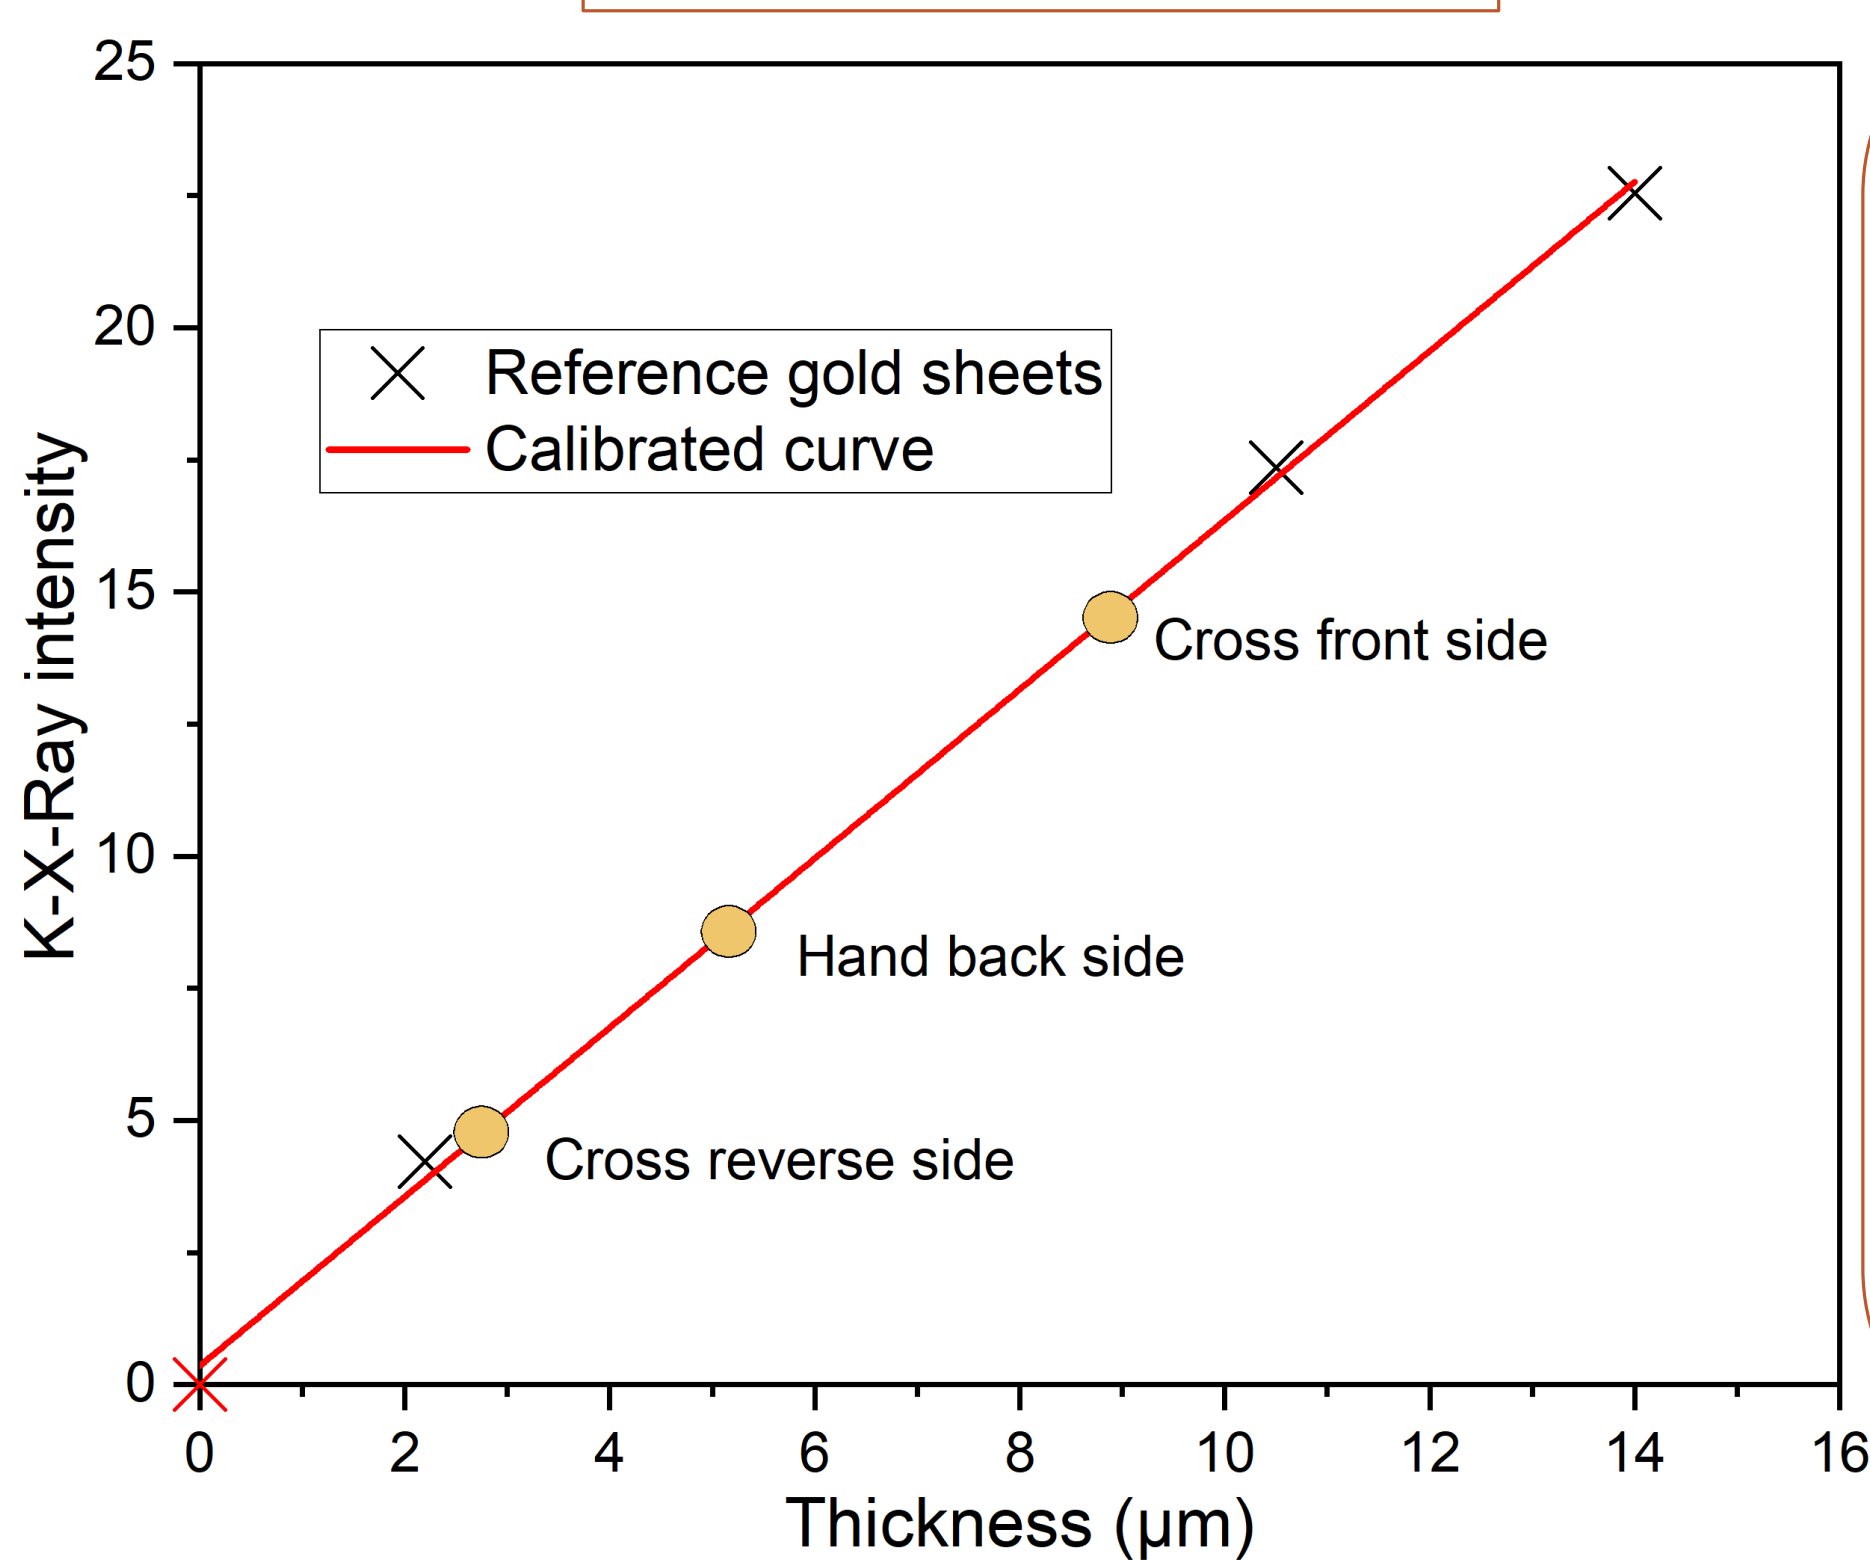
3 reference gold sheets were used, they have a thickness of 2,2, 10,5 and 14µm.

The CdTe detector was used to measure the intensity of the Au K $\alpha$  lines, X-ray attenuation in Au is negligible so the intensity of the lines is directly proportional to the thickness of gold crossed by the beam.

The thickness of the gilding is different at each point of analysis

- Cross reverse side = 2.9
- Christ's hand back side = 5.4µm
- Cross front side = 9µm

- Gilding thickness measurements are in agreement with the historical data collected during the study of comparable objects. Fire gilded bronze are mainly associated with thicknesses of 1 to 10µm.
- HE-PIXE is well suited for coating layer thickness measurements using K X-ray lines even if XRF could also be performed with L and M lines.
- Since the HE-PIXE analysis, object has been restored. Gold area are now much more visible than before.
- Further analyses need to be done with an handheld XRF device to cover all the gilded zones to conclude and say whether the Christ necessitates a thicker layer of gold than the cross.
- Other questions relating to the quality of the gilding and the work done during the elaboration of the object remain to be answered.

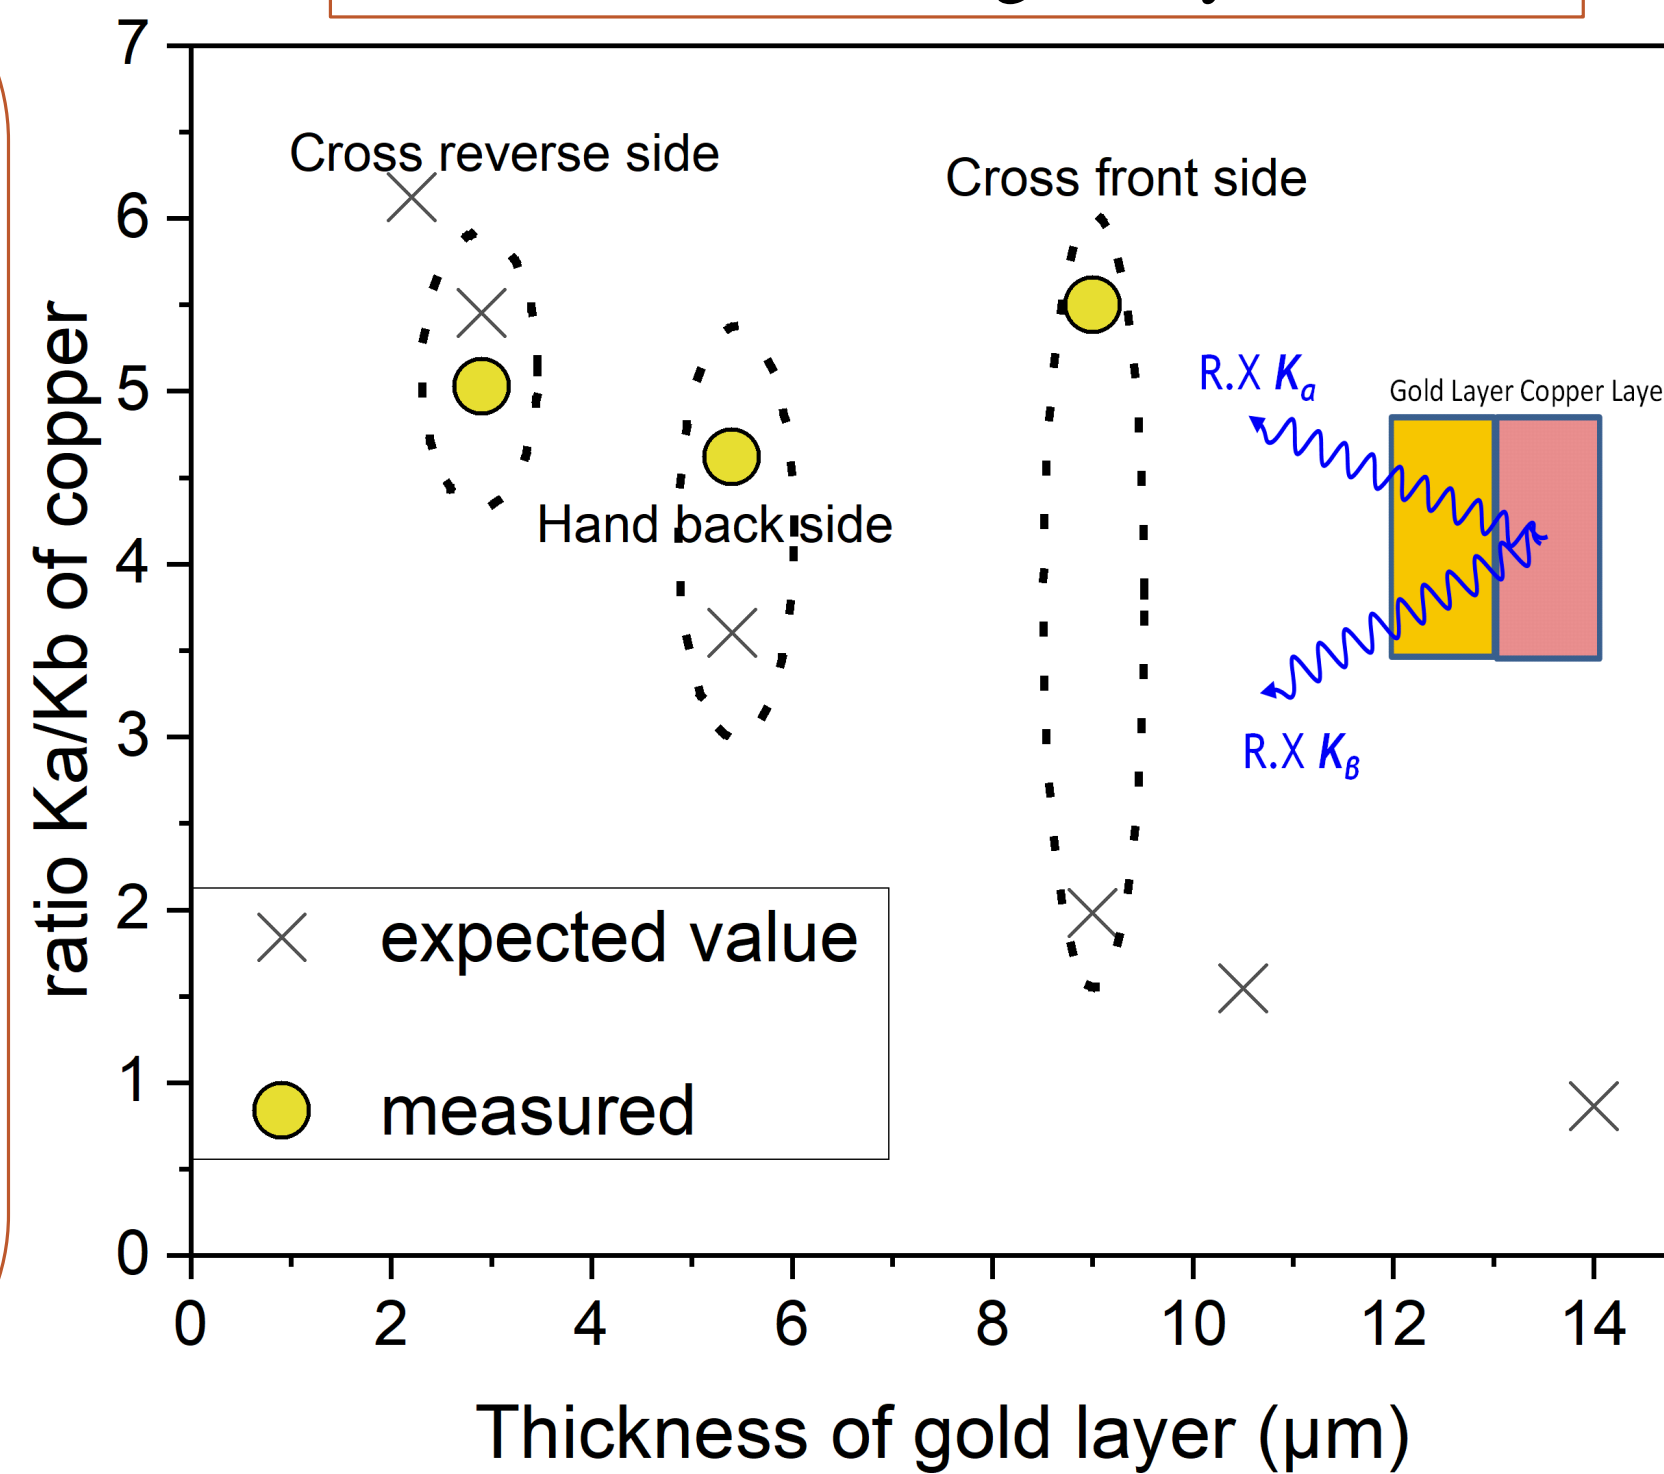
The SDD detector was used to measure the K lines intensity of copper coming from behind the gilding thickness.

Expected values are calculated using mass attenuation coefficient of gold at Ka and Kb energies of copper.

They show the logical behavior of the ratio  $K\alpha/K\beta$ , since Ka is less energetic thus more attenuated than Kb, the ratio decreases when the thickness increases.

Experimental values do not fit exactly to the expected ones, this can be explained by a surface heterogeneity of the gold layer. Currently, the gold thickness is an average measurement over the irradiated area and the ratio of the copper K-lines depends strongly on the actual thickness fluctuation.
