## High energy ion beam analysis of cultural heritage objects, a study of provenance and manufacturing techniques

# High energy ion beam analysis of cultural heritage objects, a study of provenance and manufacturing techniques

## Historical context and questions concerning the object

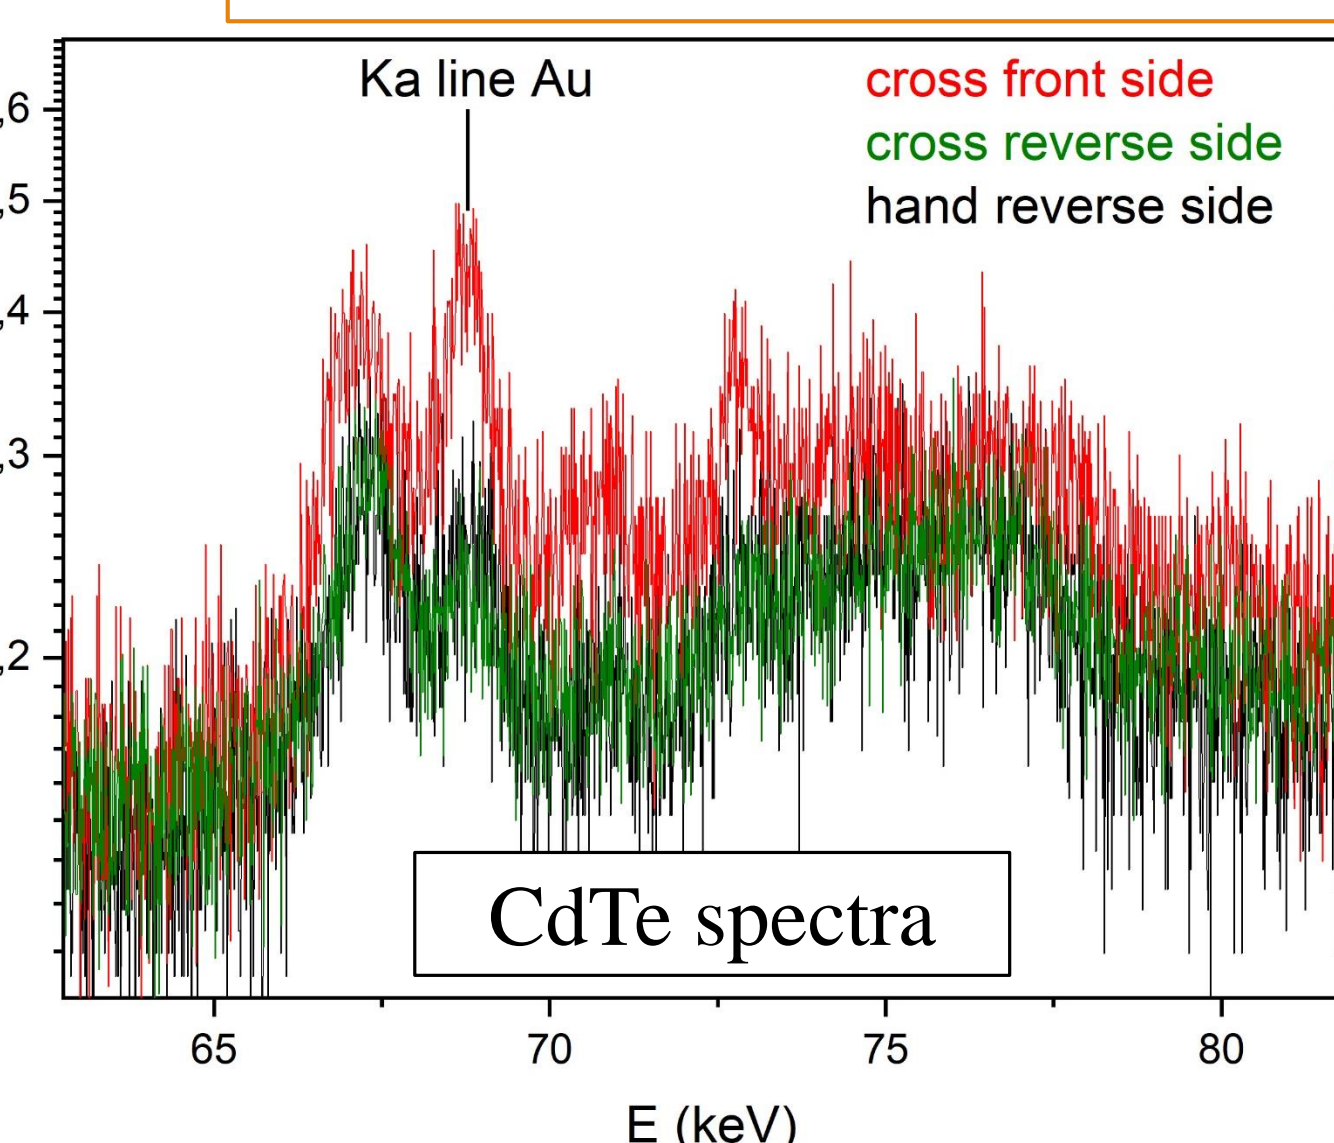
Cu/Zn	brass
Sn/Pb/Sb/Ti/Mn/Fe/Ni	alloying additions
Au/Hg/Ag	gilding
Si	SDD detector
Ar	air
Ca	surface contaminant

Coupling SDD for low energy X-rays (<15keV) with CdTe for higher energies up to 100keV.

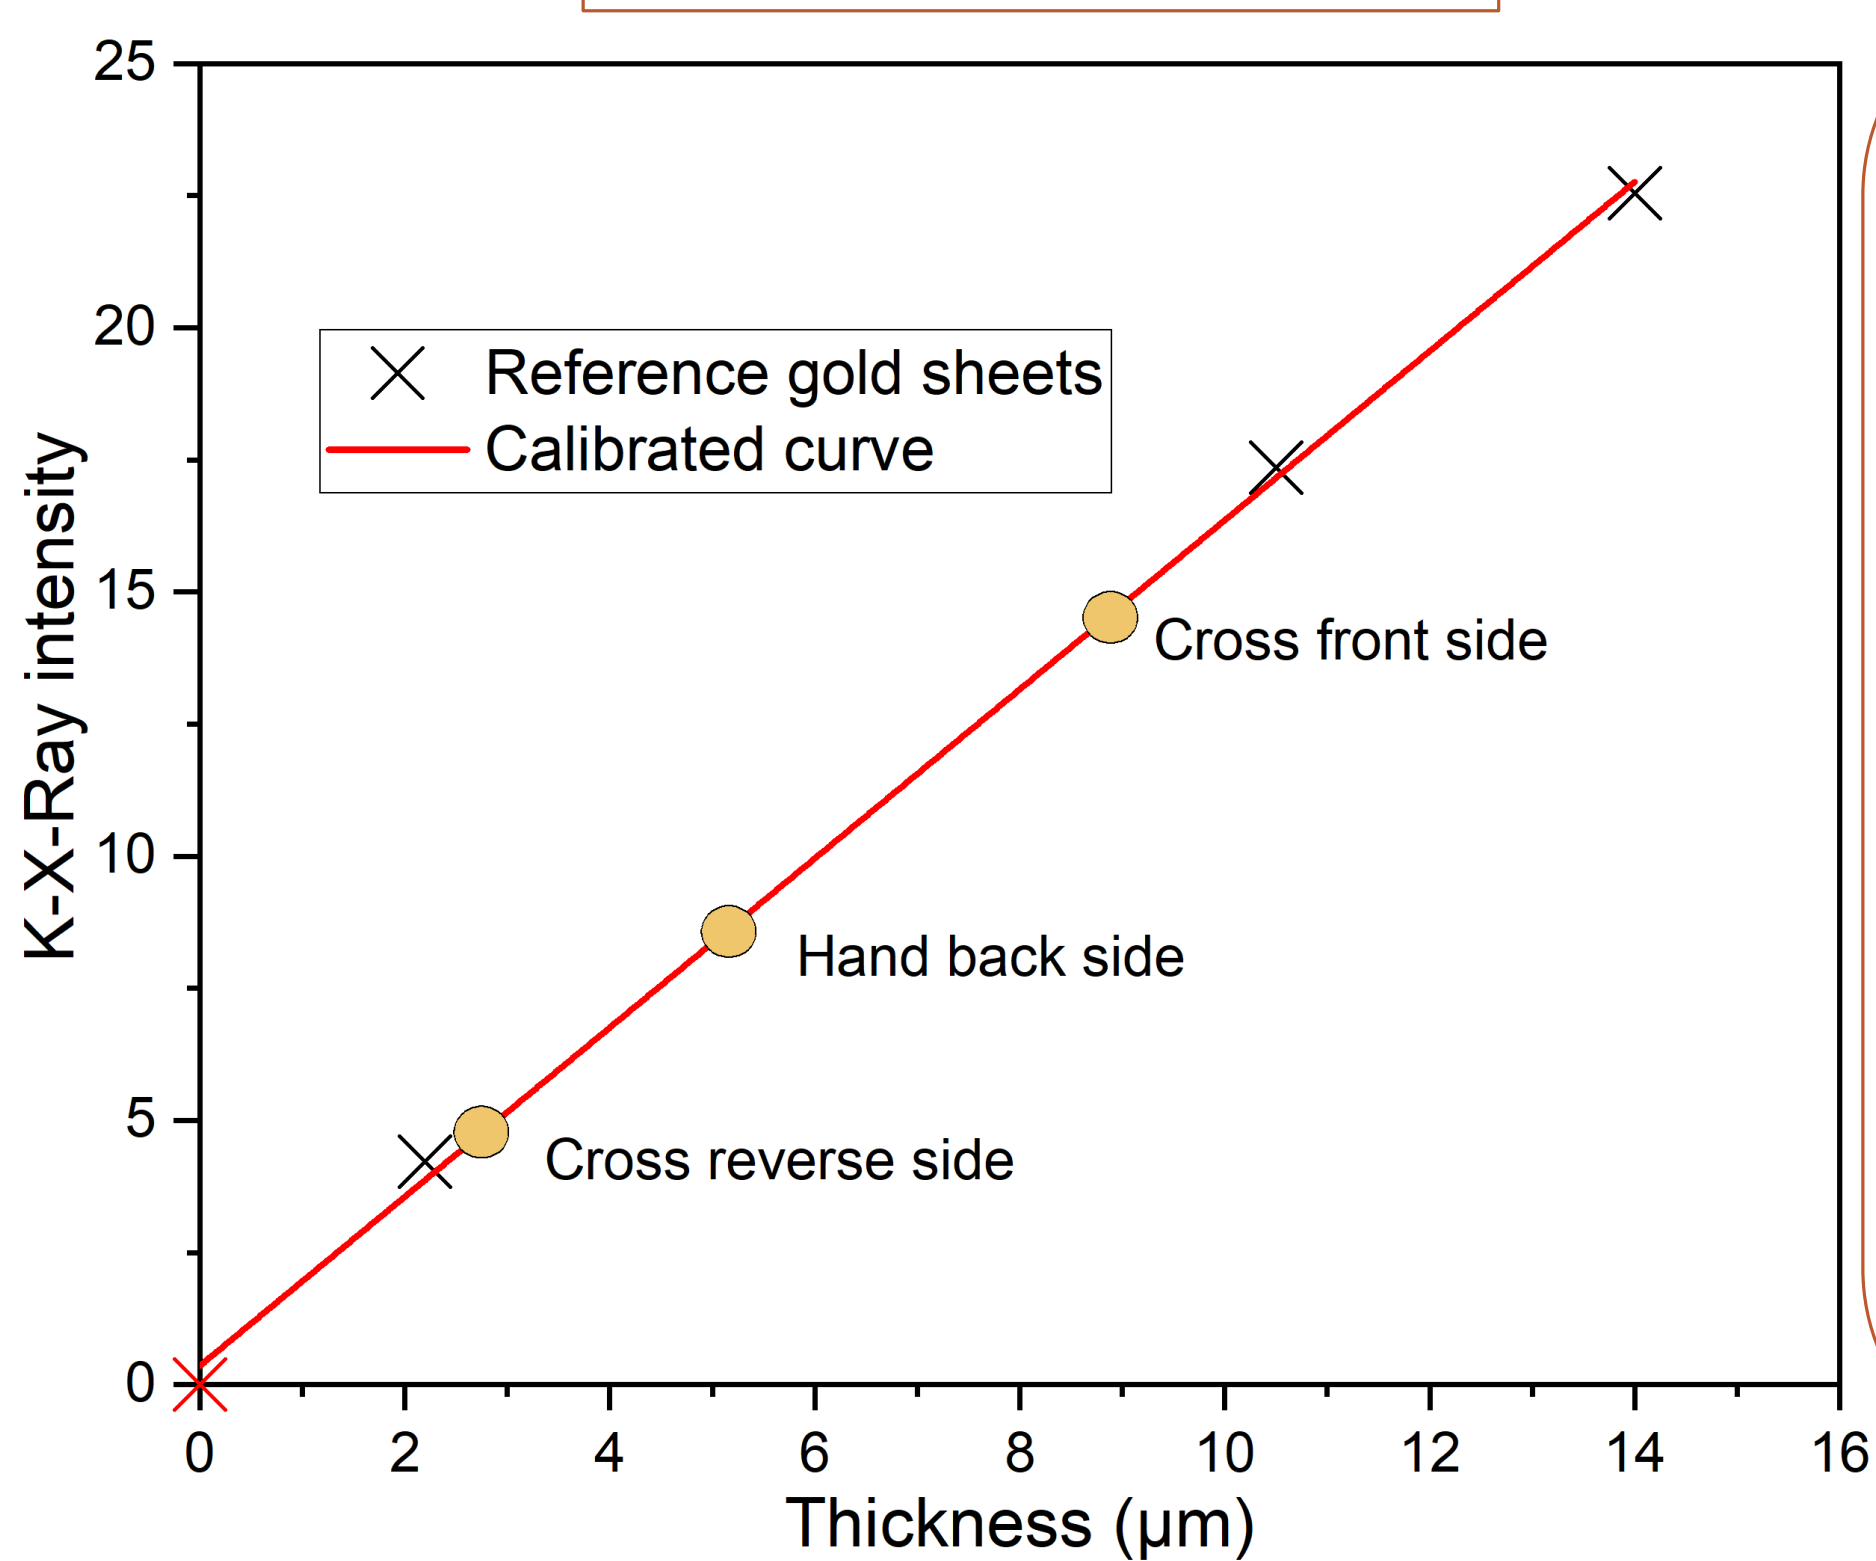
3 reference gold sheets were used, they have a thickness of 2,2, 10,5 and 14µm.

The CdTe detector was used to measure the intensity of the Au K<sub>α</sub> lines, X-ray attenuation in Au is negligible so the intensity of the lines is directly proportional to the thickness of gold crossed by the beam.

The thickness of the gilding is different at each point of analysis

- Cross reverse side = 2.9
- Christ's hand back side = 5.4µm
- Cross front side = 9µm
