## High energy ion beam analysis of cultural heritage objects, a study of provenance and manufacturing techniques

# High energy ion beam analysis of cultural heritage objects, a study of provenance and manufacturing techniques

## Historical context and questions concerning the object

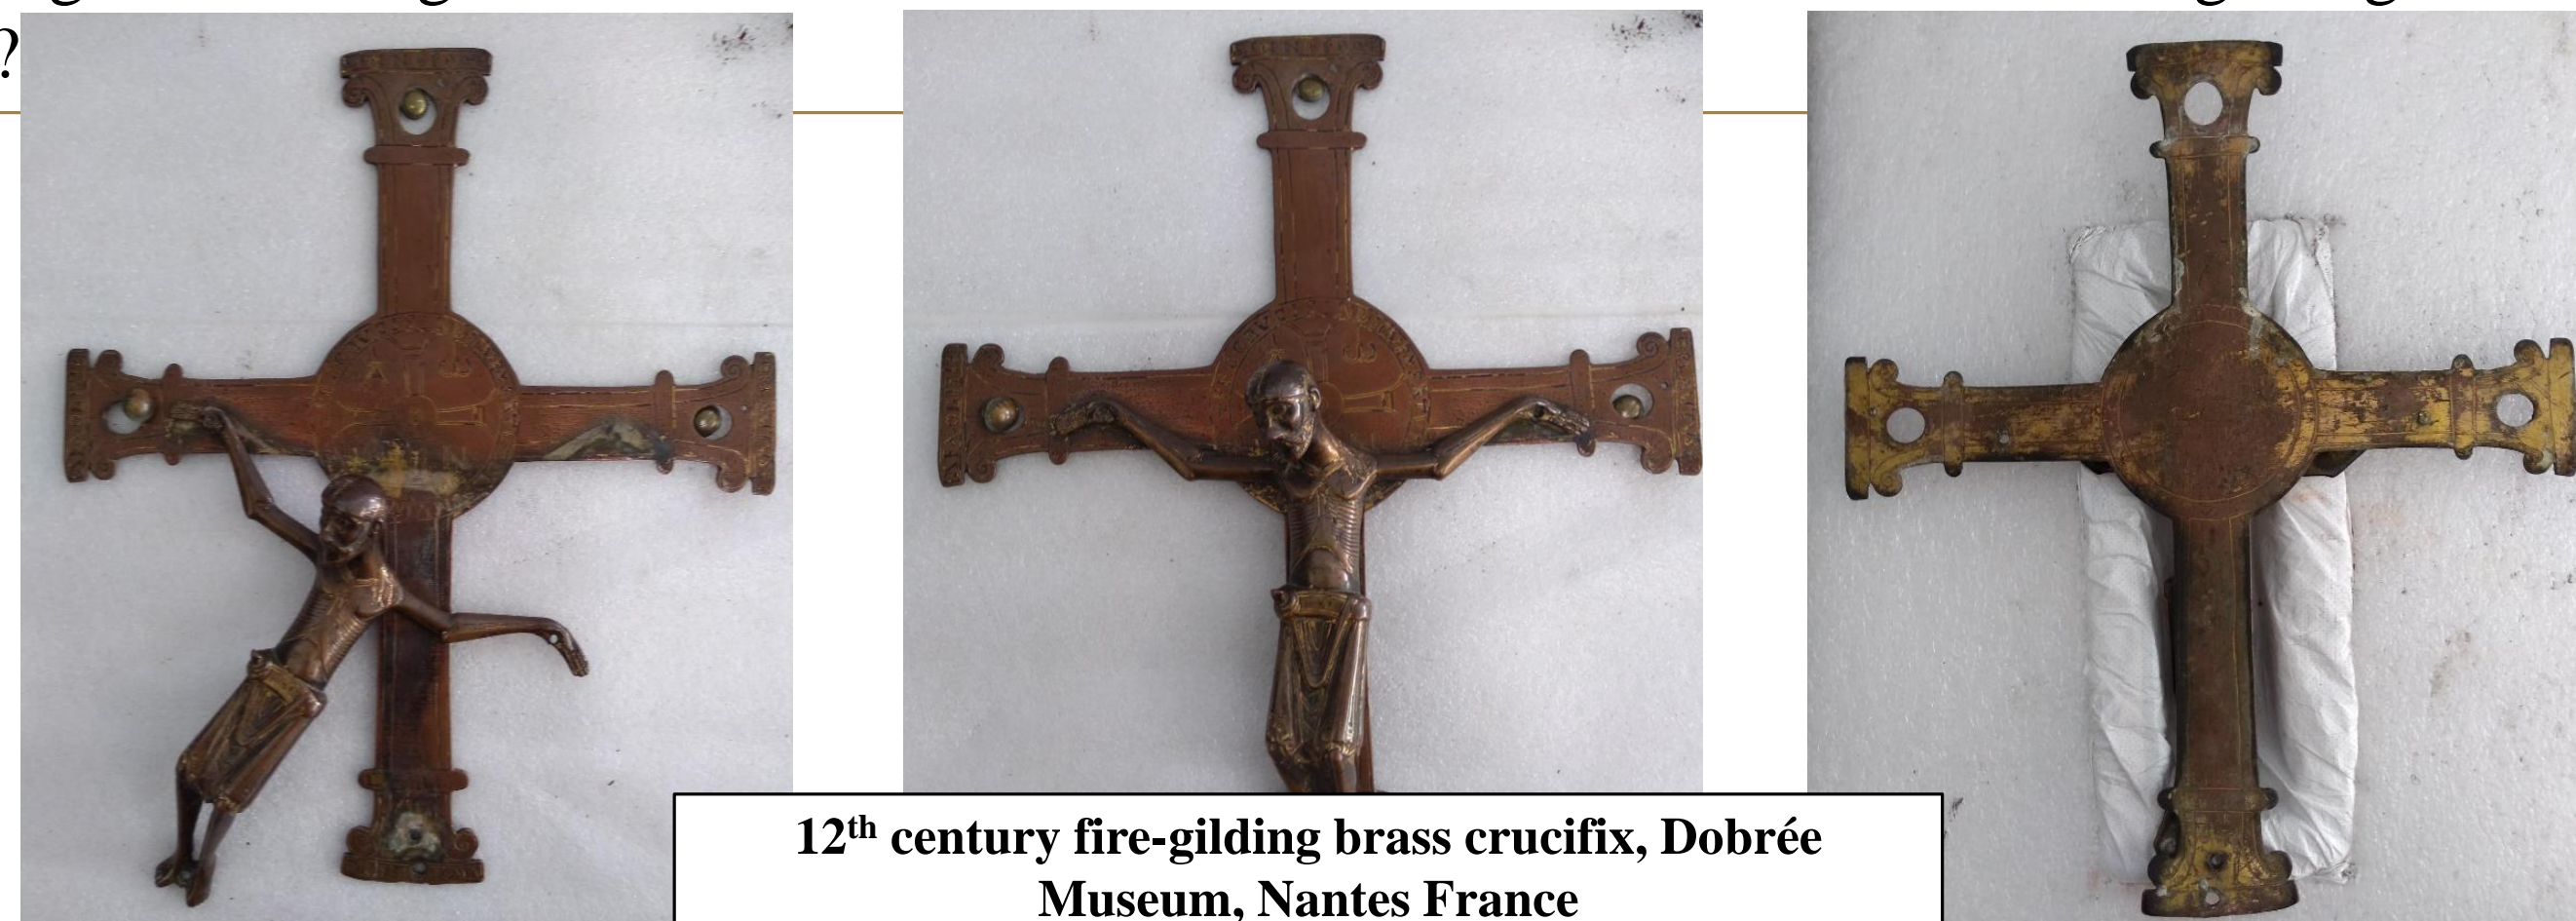
12th century fire-gilding brass crucifix, Dobrée Museum, Nantes France

We studied a 12th century Romanesque crucifix. Fire-gilding was used to cover the Christ and his cross. The study of coating thickness can improve the understanding of the manufacturing technique used in the case of fire-gilding on a brass alloy [1].

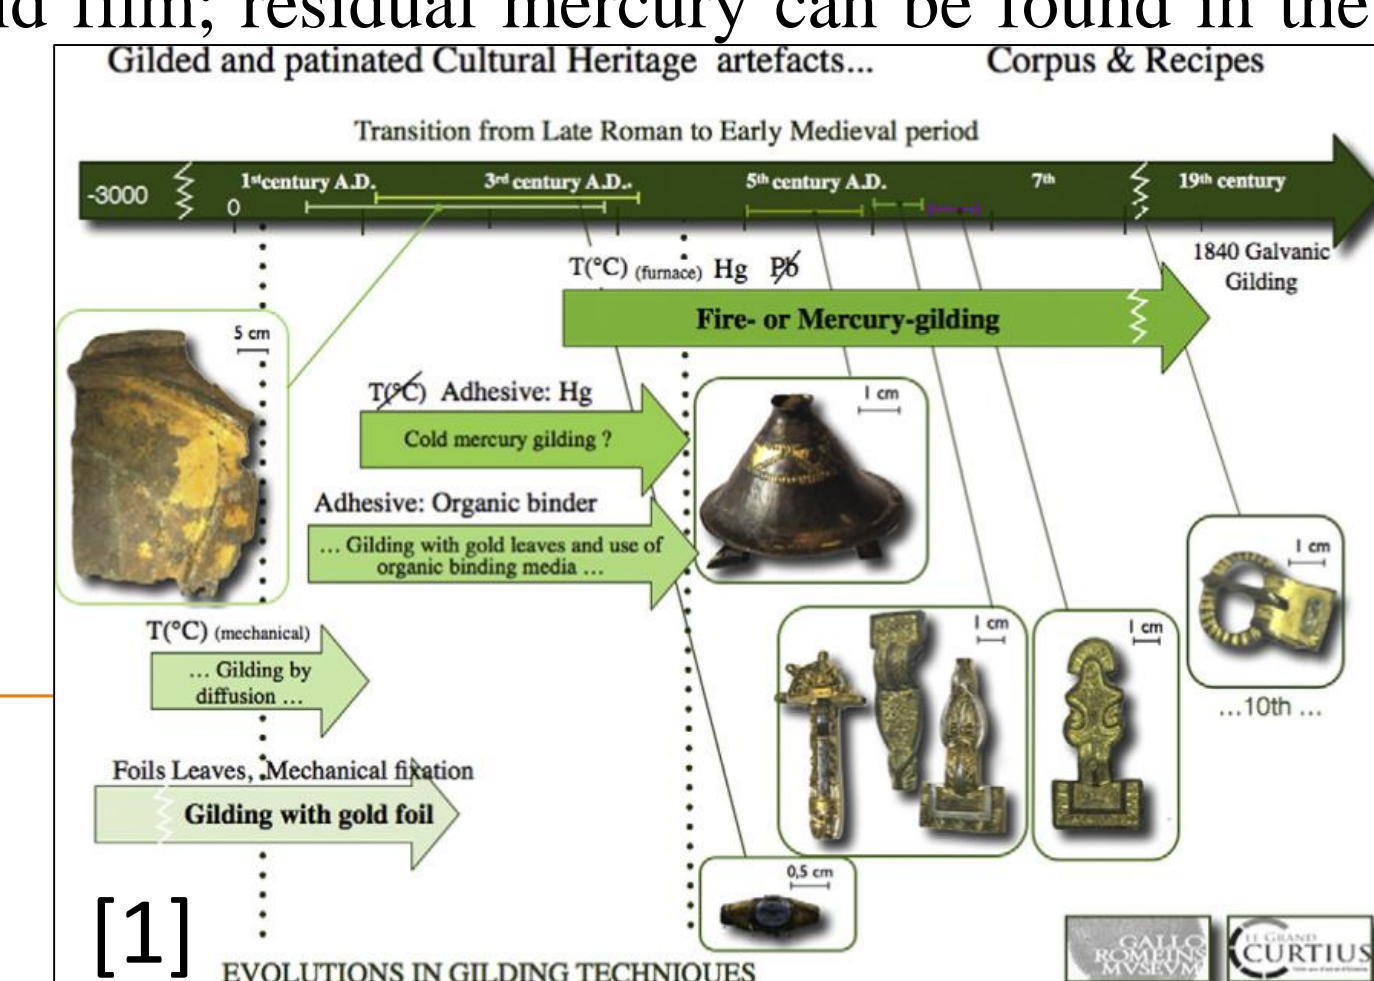
Fire gilding has been performed from 3rd to 19th century to decorate objects mainly bronze and brass statuette. It is a diffusion bonding process. The role of the mercury is to ensure a close contact of substrate and plating. There is a solid-state reaction involving the use of a paste of Au-Hg amalgam (Au<sub>2</sub>Hg) [2].

**Step n°1 - Grinding gold dust with mercury;** it requires a clean and oxide-free metal substrate

**Step n°2 - Thermal treatment;** it takes a few minutes by heating in air at about 250–350°C (< Hg boiling point at 357°C)

**Step n°3 - Mechanical finishing** using burnishers

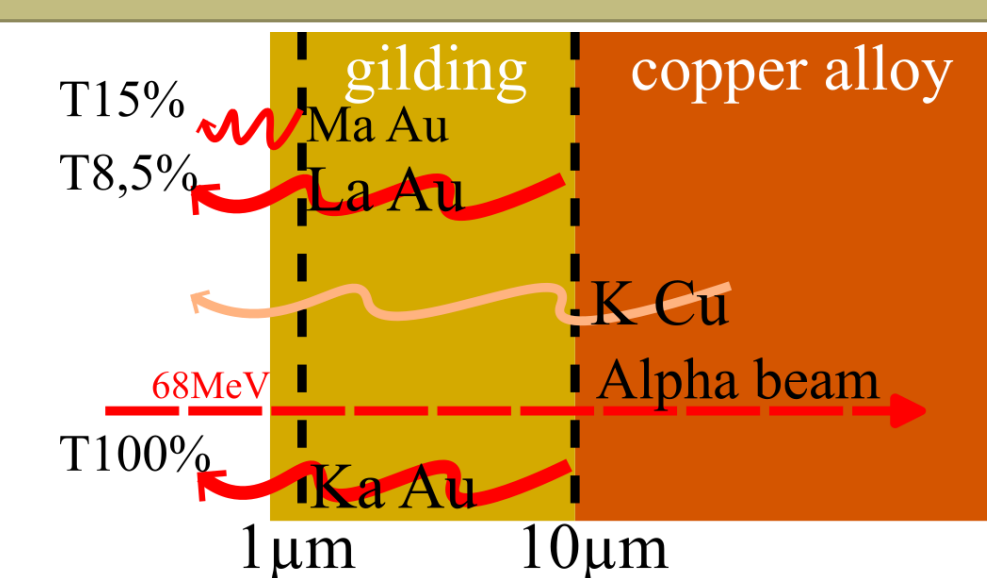
For our purpose, coating thickness measurement can be done with the net intensity of Au K-X ray line (because self attenuation is negligible, see diagram beside). Furthermore, the gilding quality was evaluated by studying the variation of the ratios  $K_{\alpha}/K_{\beta}$  of copper in gold.

Specific X-ray lines attenuated through gilding layer and copper matrix

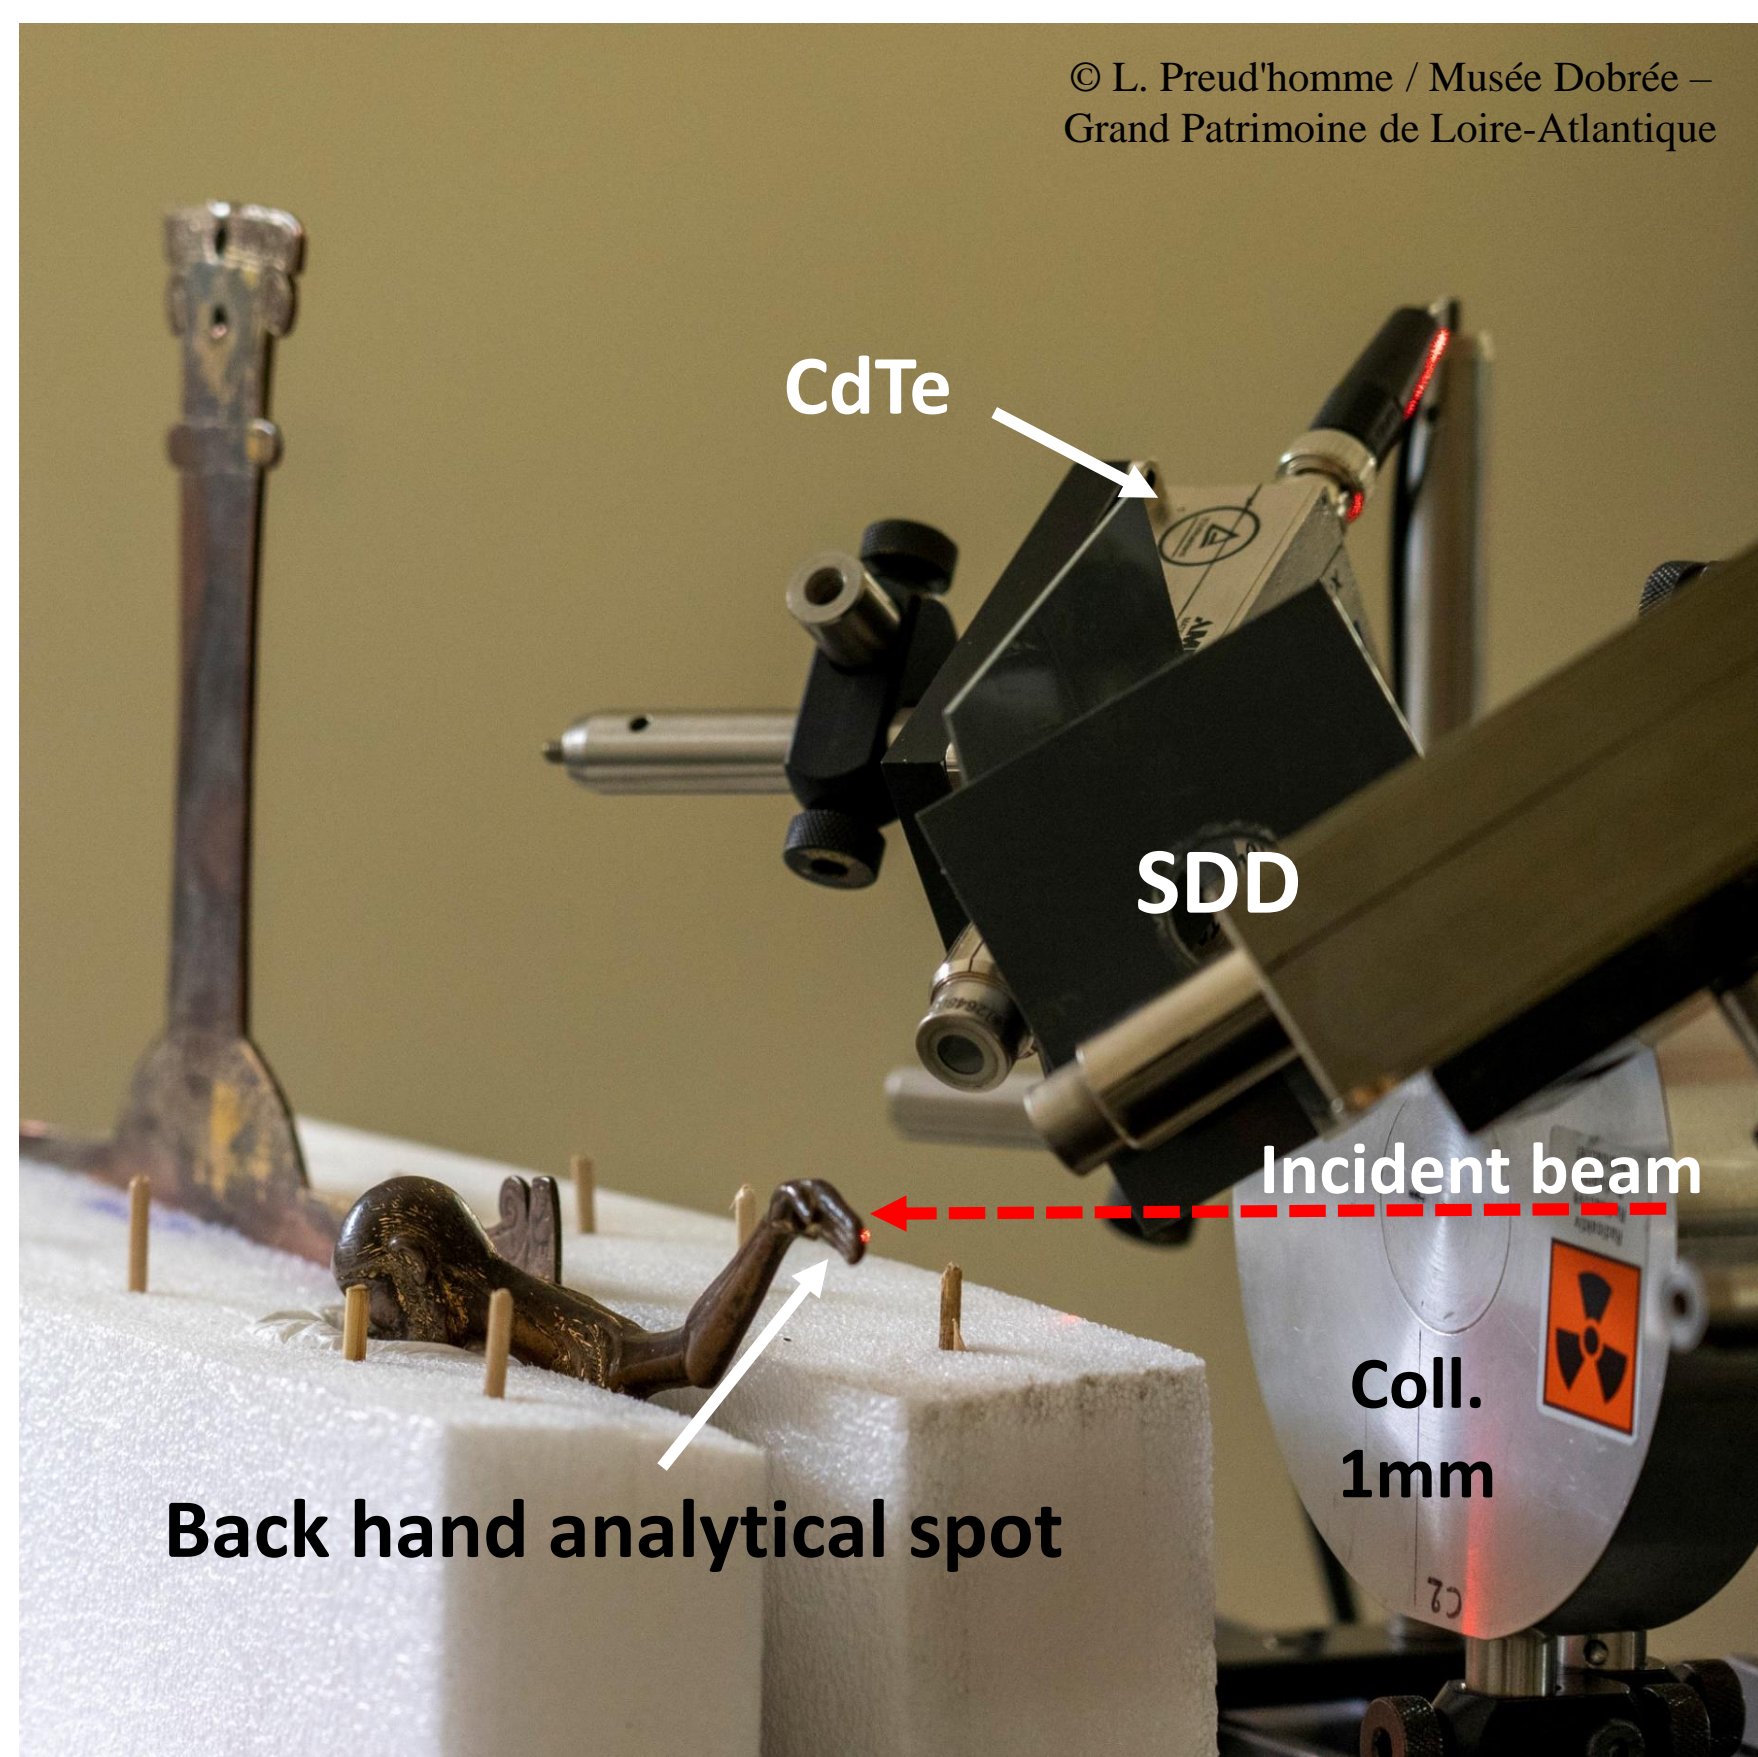
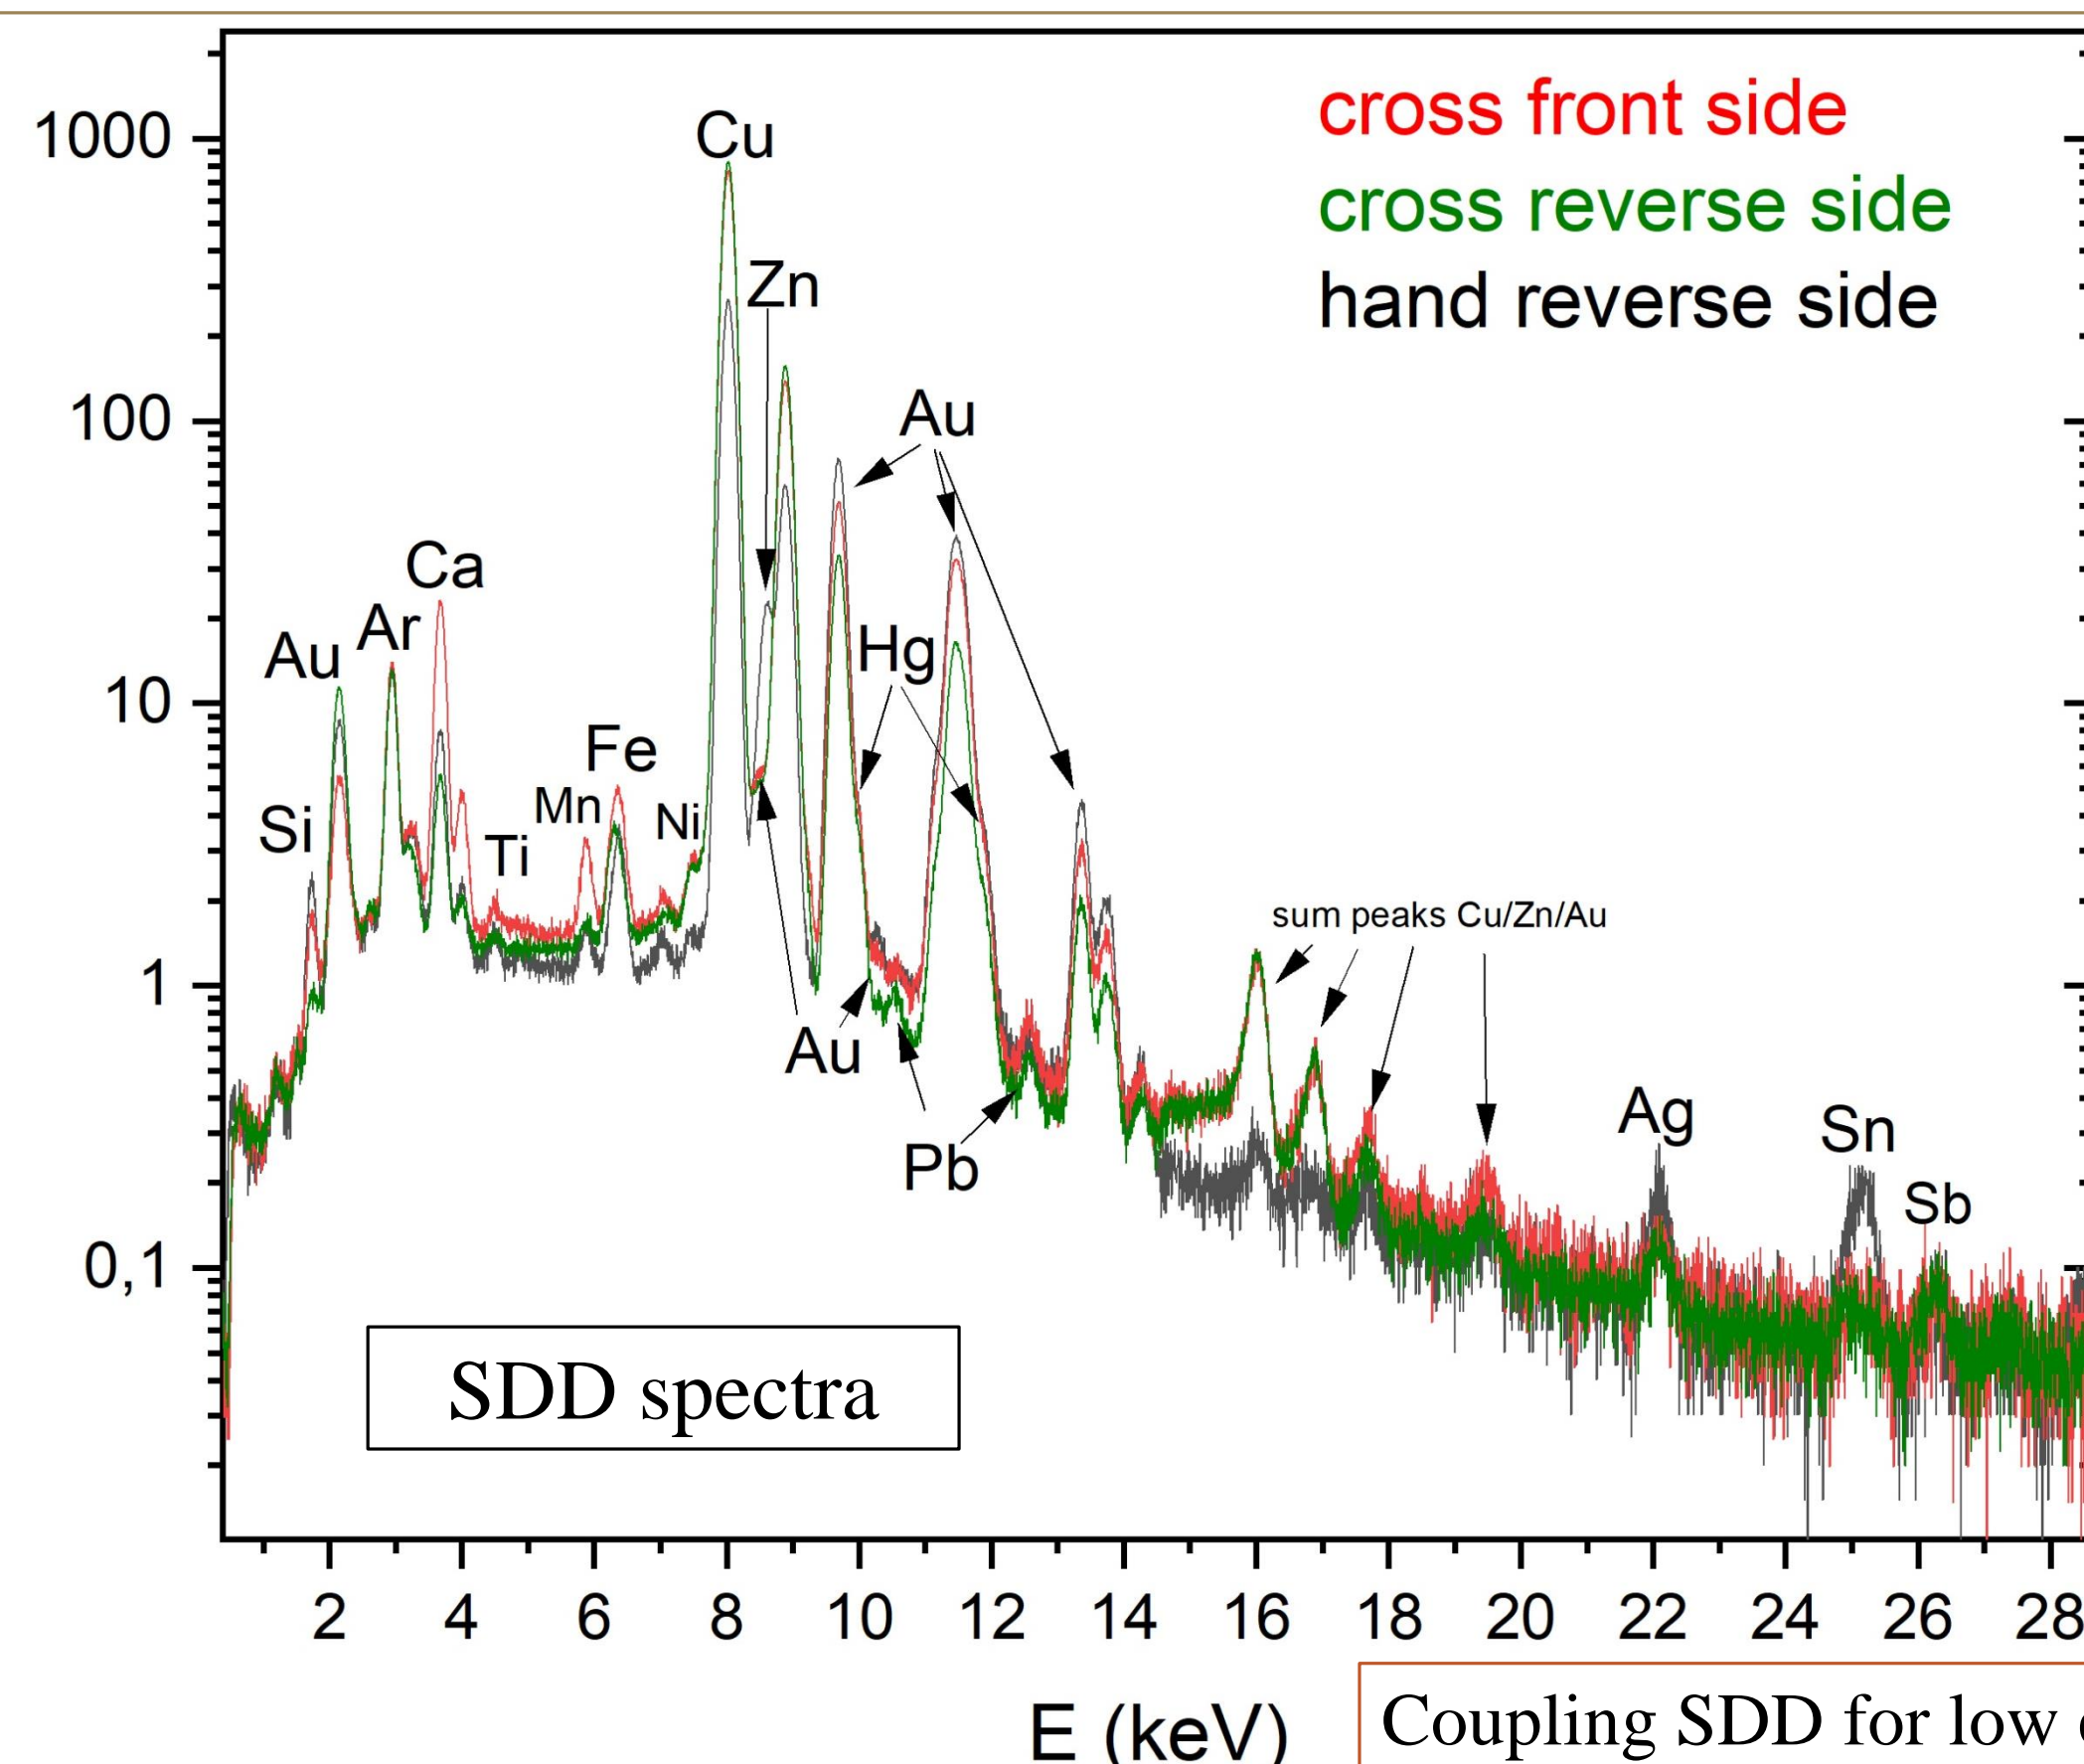
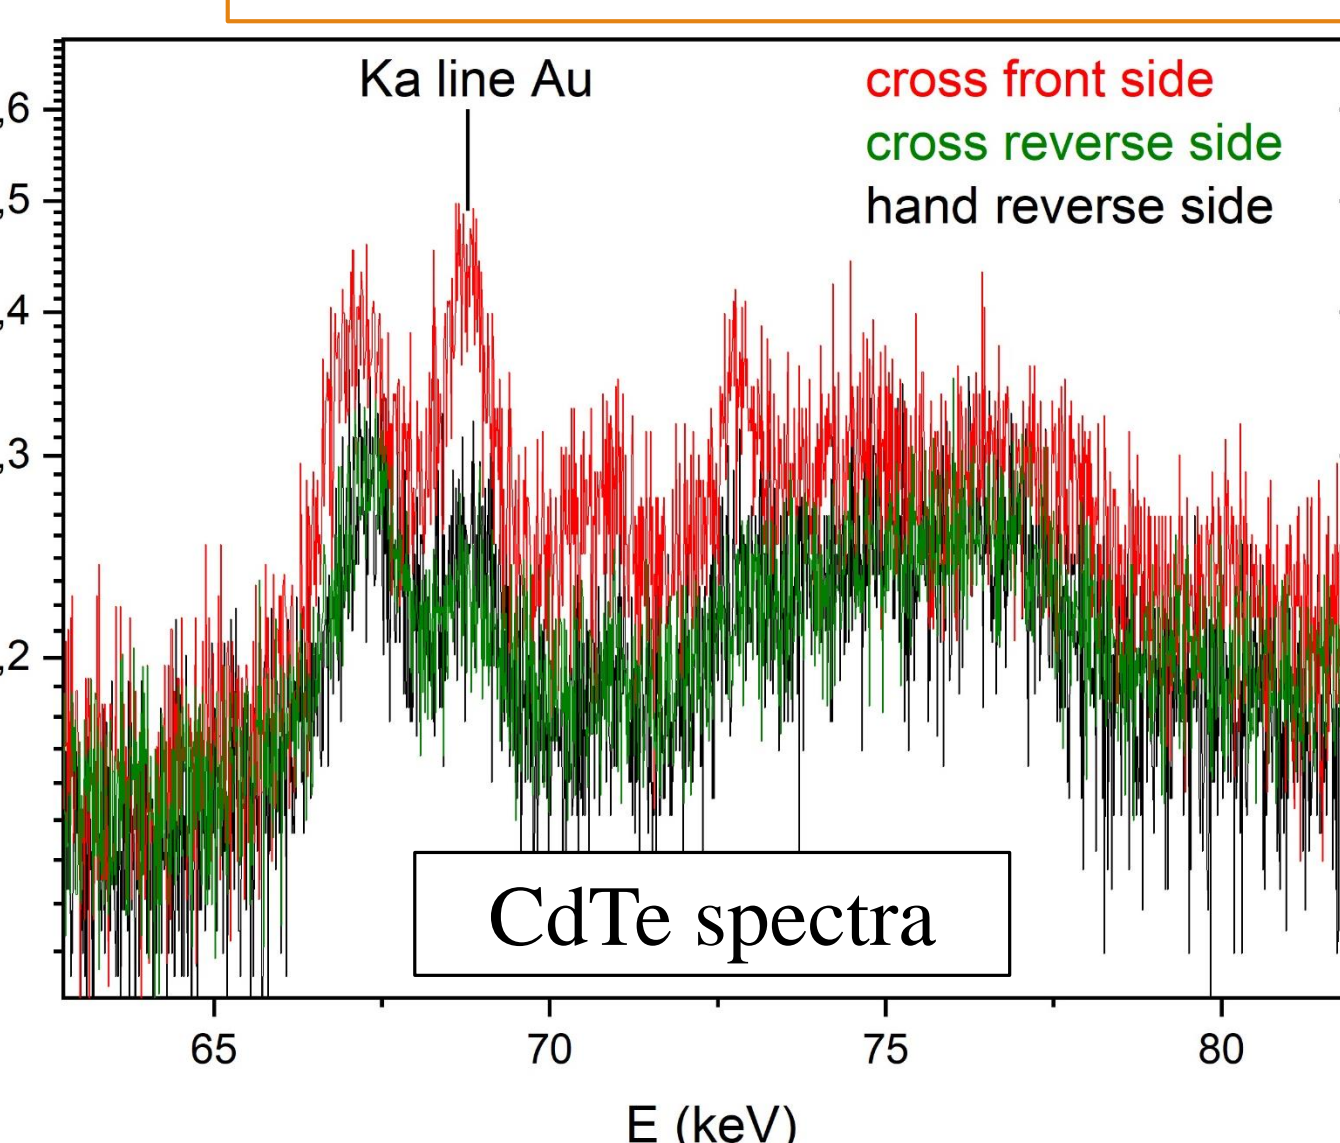
Cu/Zn	brass
Sn/Pb/Sb/Ti/Mn/Fe/Ni	alloying additions
Au/Hg/Ag	gilding
Si	SDD detector
Ar	air
Ca	surface contaminant

Coupling SDD for low energy X-rays (<15keV) with CdTe for higher energies up to 100keV.

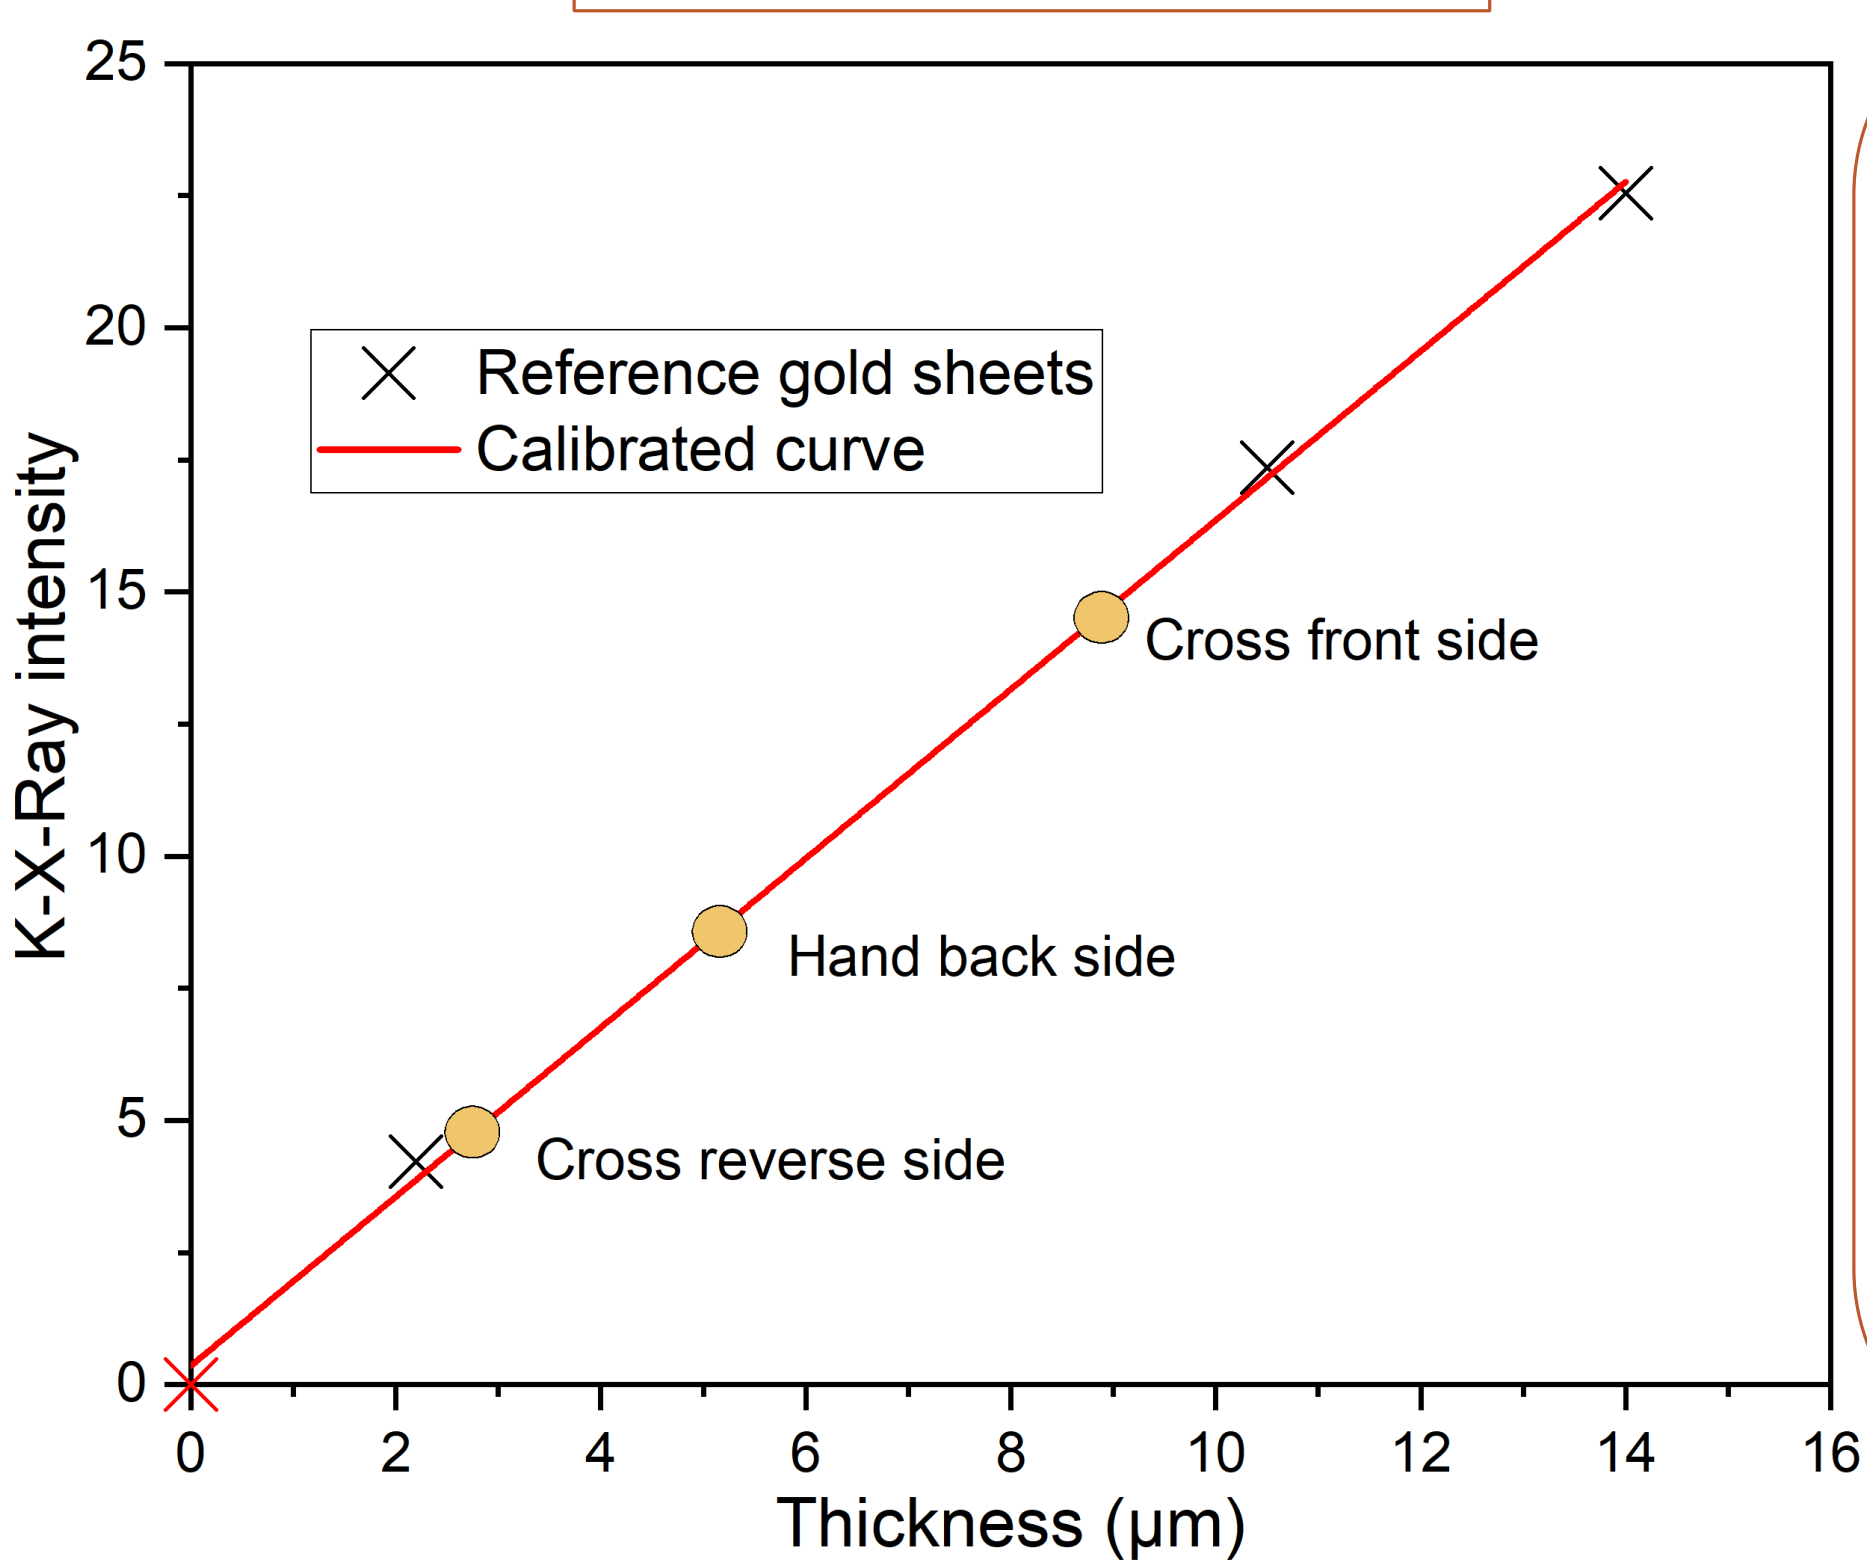
3 reference gold sheets were used, they have a thickness of 2,2, 10,5 and 14µm.

The CdTe detector was used to measure the intensity of the Au K<sub>α</sub> lines, X-ray attenuation in Au is negligible so the intensity of the lines is directly proportional to the thickness of gold crossed by the beam.

The thickness of the gilding is different at each point of analysis

- Cross reverse side = 2.9
- Christ's hand back side = 5.4µm
- Cross front side = 9µm

- Gilding thickness measurements are in agreement with the historical data collected during the study of comparable objects. Fire gilded bronze are mainly associated with thicknesses of 1 to 10µm.
- HE-PIXE is well suited for coating layer thickness measurements using K X-ray lines even if XRF could also be performed with L and M lines.
- Since the HE-PIXE analysis, object has been restored. Gold area are now much more visible than before.
- Further analyses need to be done with an handheld XRF device to cover all the gilded zones to conclude and say whether the Christ necessitates a thicker layer of gold than the cross.
- Other questions relating to the quality of the gilding and the work done during the elaboration of the object remain to be answered.

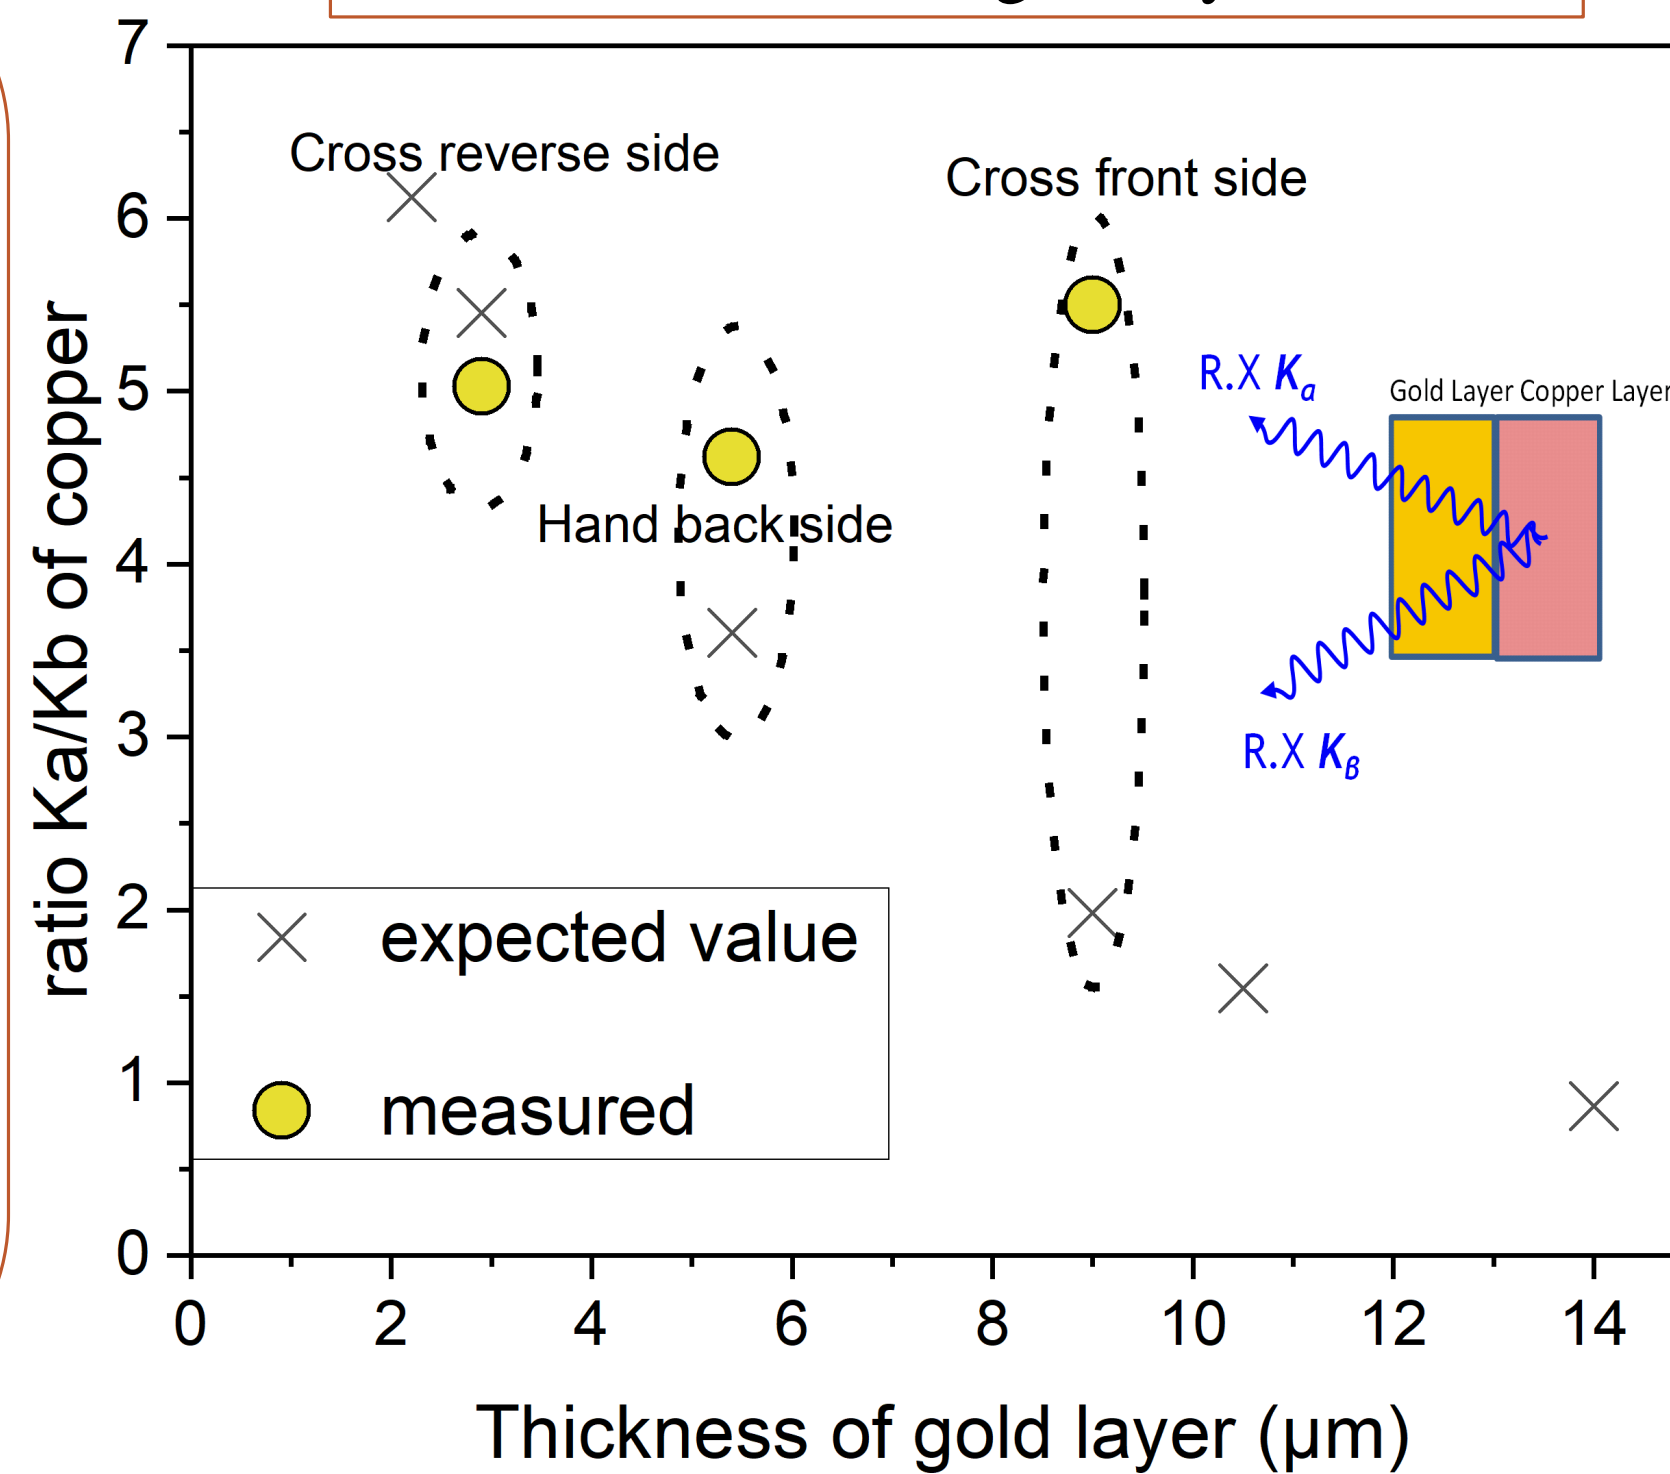
The SDD detector was used to measure the K lines intensity of copper coming from behind the gilding thickness.

Expected values are calculated using mass attenuation coefficient of gold at K<sub>α</sub> and K<sub>β</sub> energies of copper.

They show the logical behavior of the ratio  $K_{\alpha}/K_{\beta}$ , since K<sub>α</sub> is less energetic thus more attenuated than K<sub>β</sub>, the ratio decreases when the thickness increases.

Experimental values do not fit exactly to the expected ones, this can be explained by a surface heterogeneity of the gold layer. Currently, the gold thickness is an average measurement over the irradiated area and the ratio of the copper K-lines depends strongly on the actual thickness fluctuation.
